## **Shermanbury Place in Historic Maps, Photos and Images (*R. S. Gordon, September 2022*)**

This document aims to illustrate the changes to the Shermanbury Estate from the earliest 1813 Ordnance Survey (OS) edition via the 1840 tithe map and a series of subsequent 6 inch and 25 inch scale maps; both levels of detail included due to differing years of publication. A map drawn up for the 1879 sale brochure (likely based on an OS map) is also included.

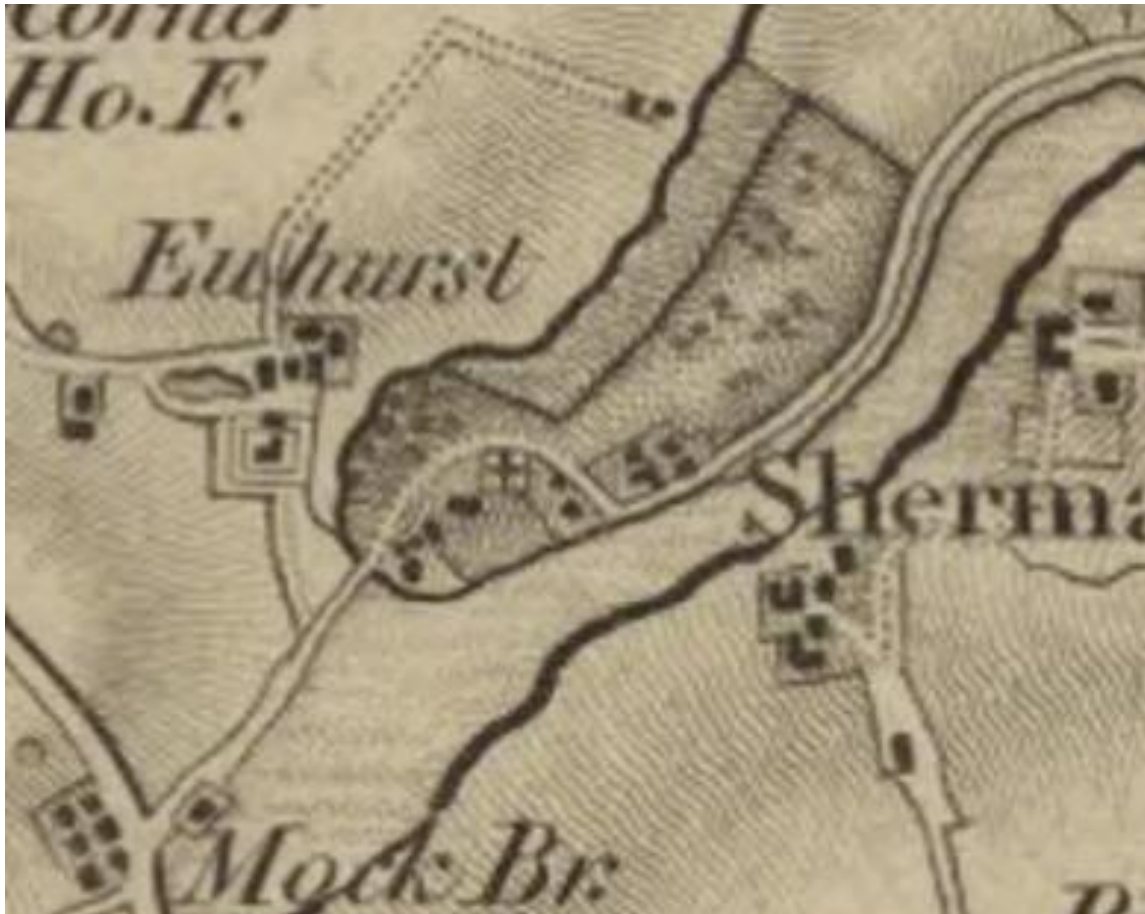
### 1. 1813 (1<sup>st</sup> edition) Ordnance Survey

The first map produced with any degree of detail on individual structures, at this stage the footprint of the house may well reflect the basic 1780 rebuild. The water mill and buildings ancillary to it and the house can be seen to the immediate south-west. The stables and another building can be seen to the east of the church. Just to the east lie the four main buildings of the [Shermanbury Home Farm](#). Given the date of this map, it is likely of 18<sup>th</sup> century or earlier date.

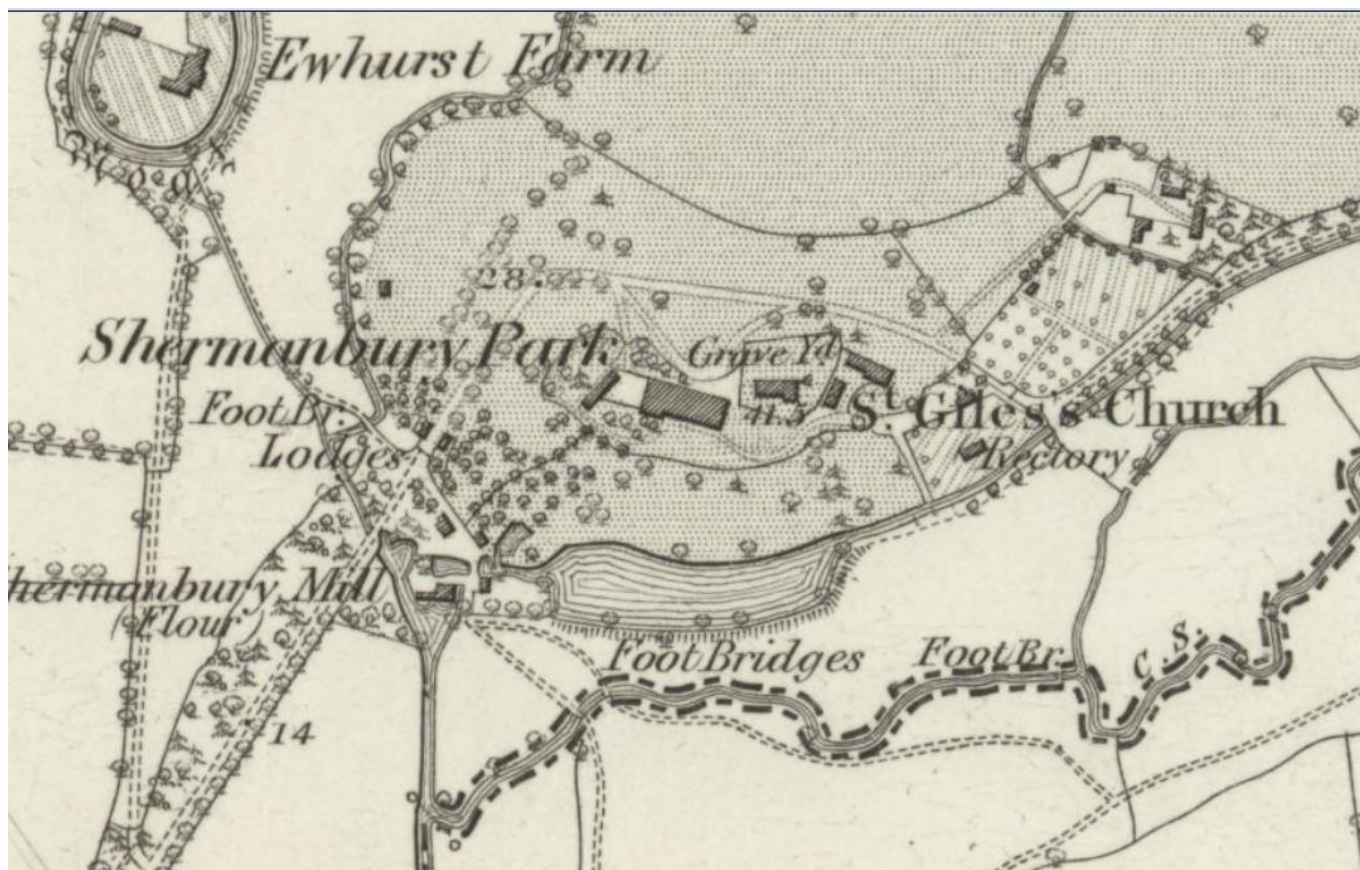
### 3. 1874-5 Ordnance Survey (6 inch, published 1879)

With the increased detail of the new edition OS maps, a clear picture can be seen. A subsequently removed long outbuilding sits west of the house. The stables are seen east of the church, along with the still existing cottage. In the 1917 sale brochure, the stables are noted as also containing the coachhouse and blacksmith's shop.

A building appears to be marked as 'Rectory'. It is possible this was the old rectory prior to the mid-19<sup>th</sup> century construction of the replacement further east at Wyndham (Wineham), but perhaps more so that the label is either mistaken or simply intended to be appended as part of the church text above. The 1879 sale brochure schedule notes this plot (211) as the kitchen garden, but doesn't mention the building. The 1917 sale brochure notes this plot as a walled kitchen and fruit garden with *'a lean-to range of glass houses with brick and tiled potting sheds.'* It also notes the structure presumably seen here as *'a Gardener's appropriate brick and tiled Cottage containing four rooms.'*

To the south-east, the quite soon to be demolished Shermanbury Home Farm is seen. The 1879 sale brochure notes that the buildings (213: Granary, barn, shedding) were all of wood, so the lack of any later trace follows. The 1917 sale brochure as a result later refers to Ewhurst Manor and its associated Farm Yard to the north (1879 schedule: 241) as the 'Home Farm'. Below the old home farm is the orchard and garden (212, 1879 schedule).

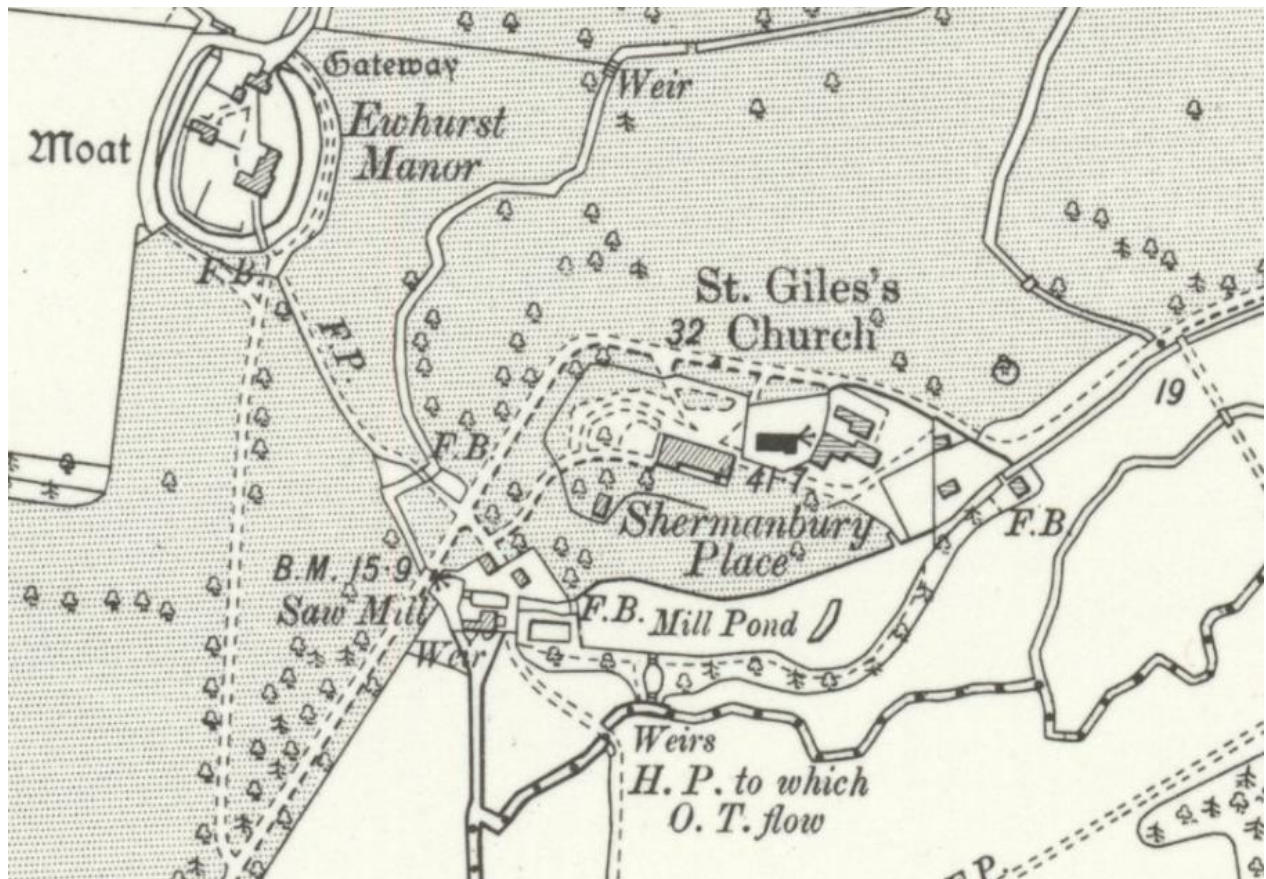
## 7. 1909 Ordnance Survey (6 inch, published 1912)

A small outbuilding appears to have been constructed just south-west of the house. Additionally, the motor garage and chauffeur's house behind the stables has now been constructed along with a club house and engine shed noted in the 1917 sale brochure. One of the small mill ponds has been squared off, likely forming the 60 by 30 foot swimming pool mentioned in the 1917 sale brochure. A small building has been added to the east of the small 'rectory' cottage to the south, perhaps relating to the weir.

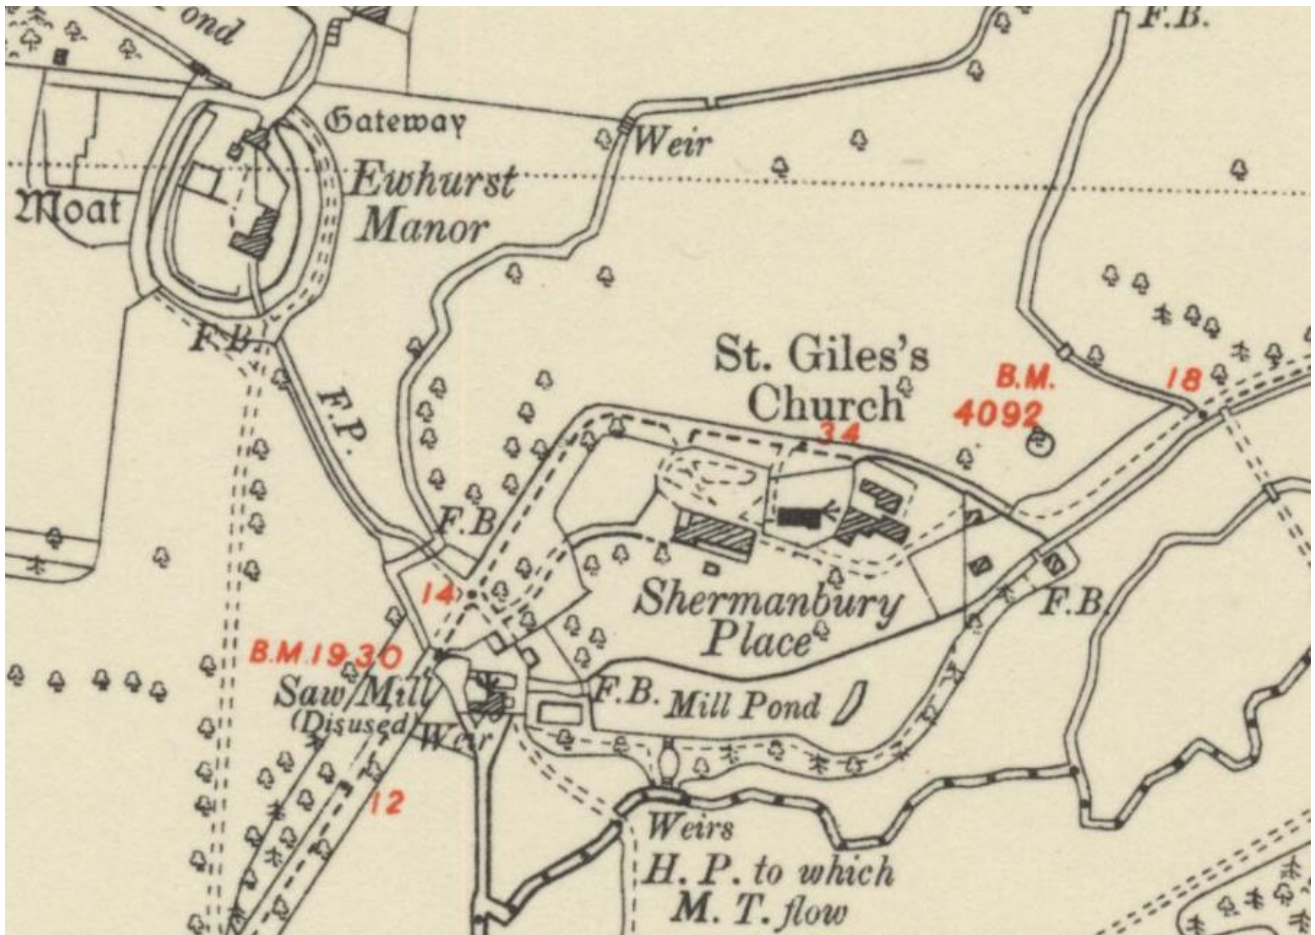
## 10. 1946-47 Ordnance Survey (6 inch, published c. 1952)

Same as above. Small 'rectory' building to the south-east still extant. Main mill building seen just prior to its post war demolition.

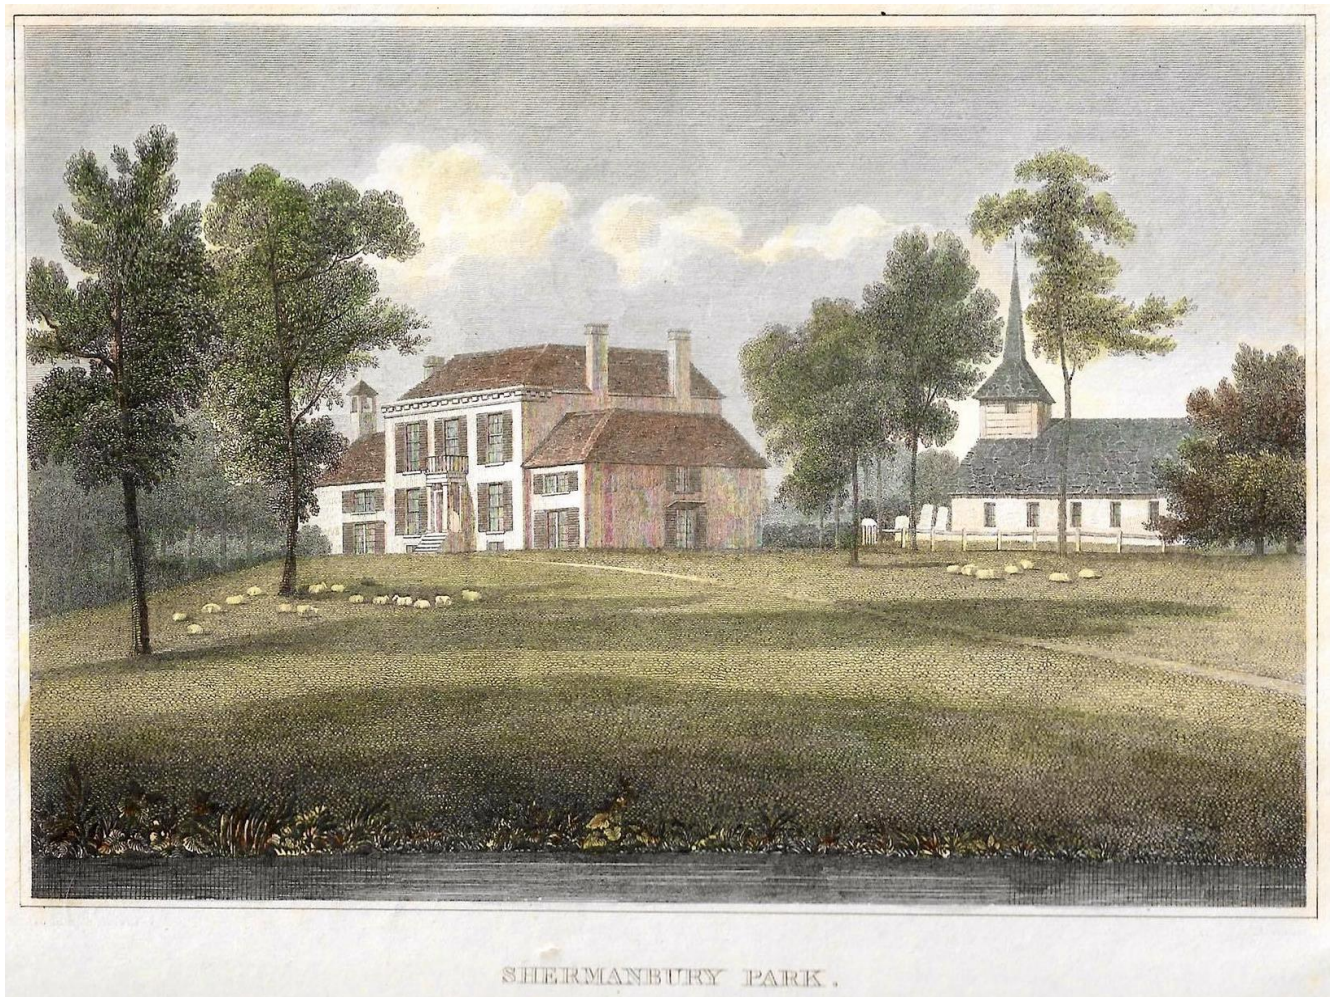
## 2. Engraving: 'Shermanbury Park' (early view from south-east)

This is a fairly well known image, also appearing in Horsfield (ibid), [where he notes](#) that it was provided to him by the current occupant, the Rev. John Gratwick Challen. This seems likely to be the form of John Challen Esq.'s functional 1780 rebuild of the house, or close to it. At this stage the house appears surrounded by simple parkland without the ornamental gardens of the earlier Tudor mansion or later iterations of the new. At least one of the low, but still two story wings likely hosted the servants' quarters.

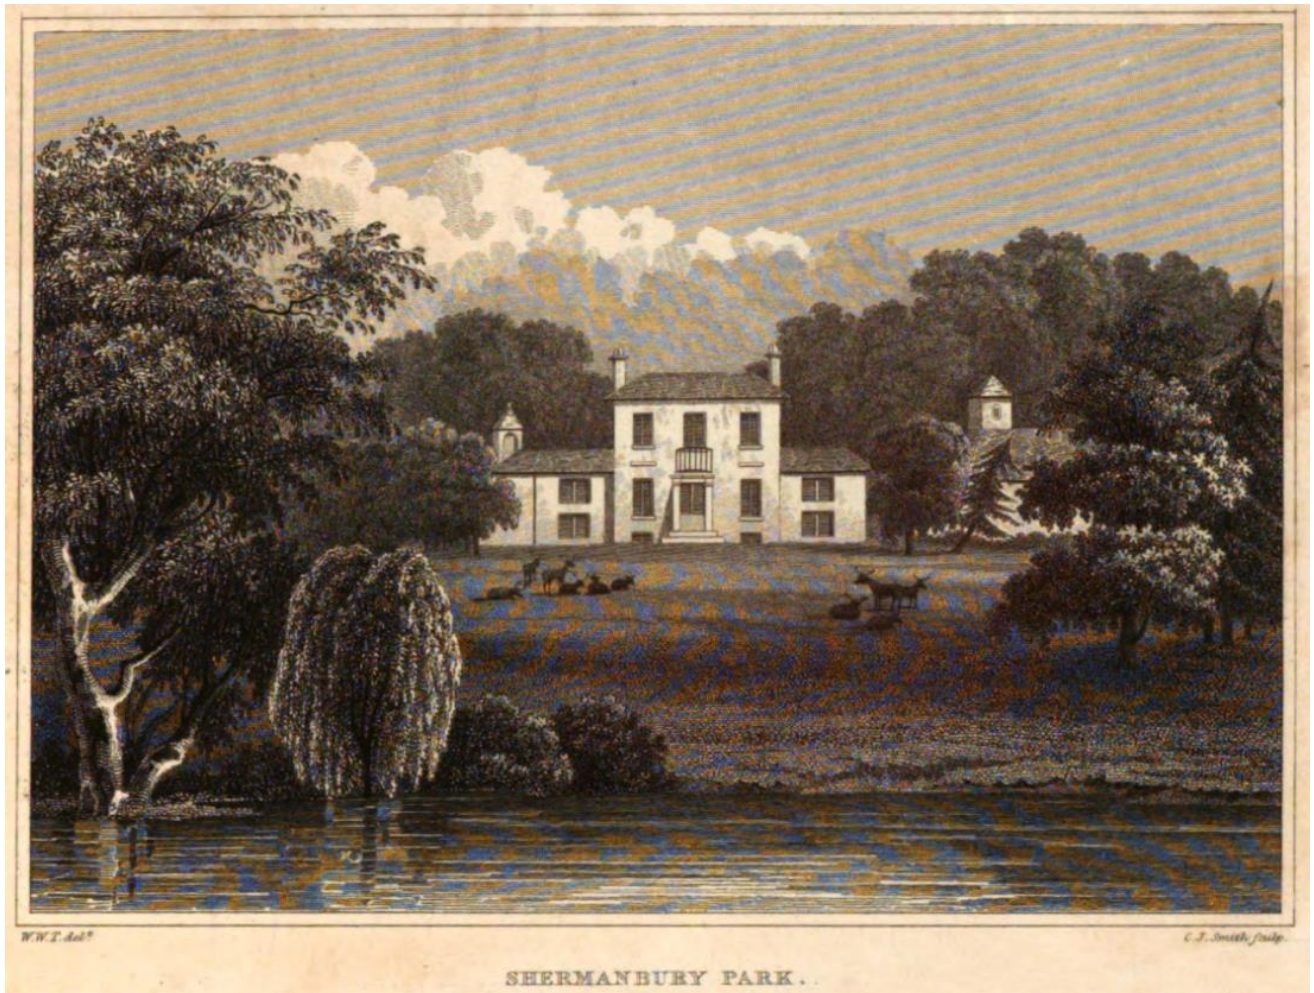
### 3. Engraving: 'Shermanbury Park' (early view from south)

Another image of the post 1780 rebuild state of the house, this from Cartwright (1830, *ibid*). The clock tower was clearly an original or early feature, perhaps also designed to be somewhat complementary to that of St. Giles'.

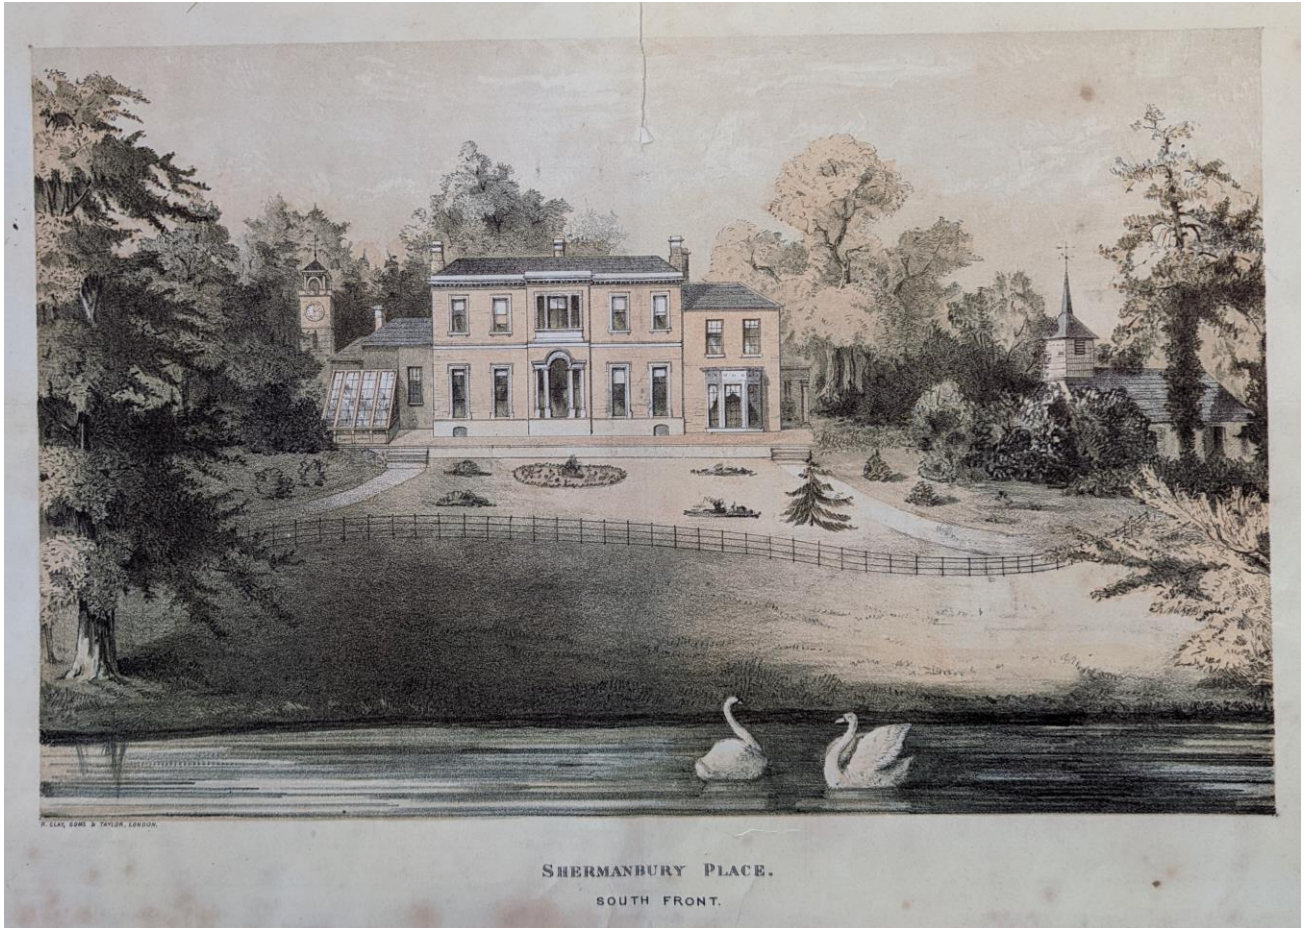
#### 4. Shermanbury Place, South Front

This image may have been drawn for the 1874 sale, but may also predate it. Although the house has the same basic form to the above two images, substantial alterations must have occurred in the decades separating them, with the central portion of the house extending from three to five bays and a more spacious first floor being added over the east wing. A simple garden has also now been laid out.

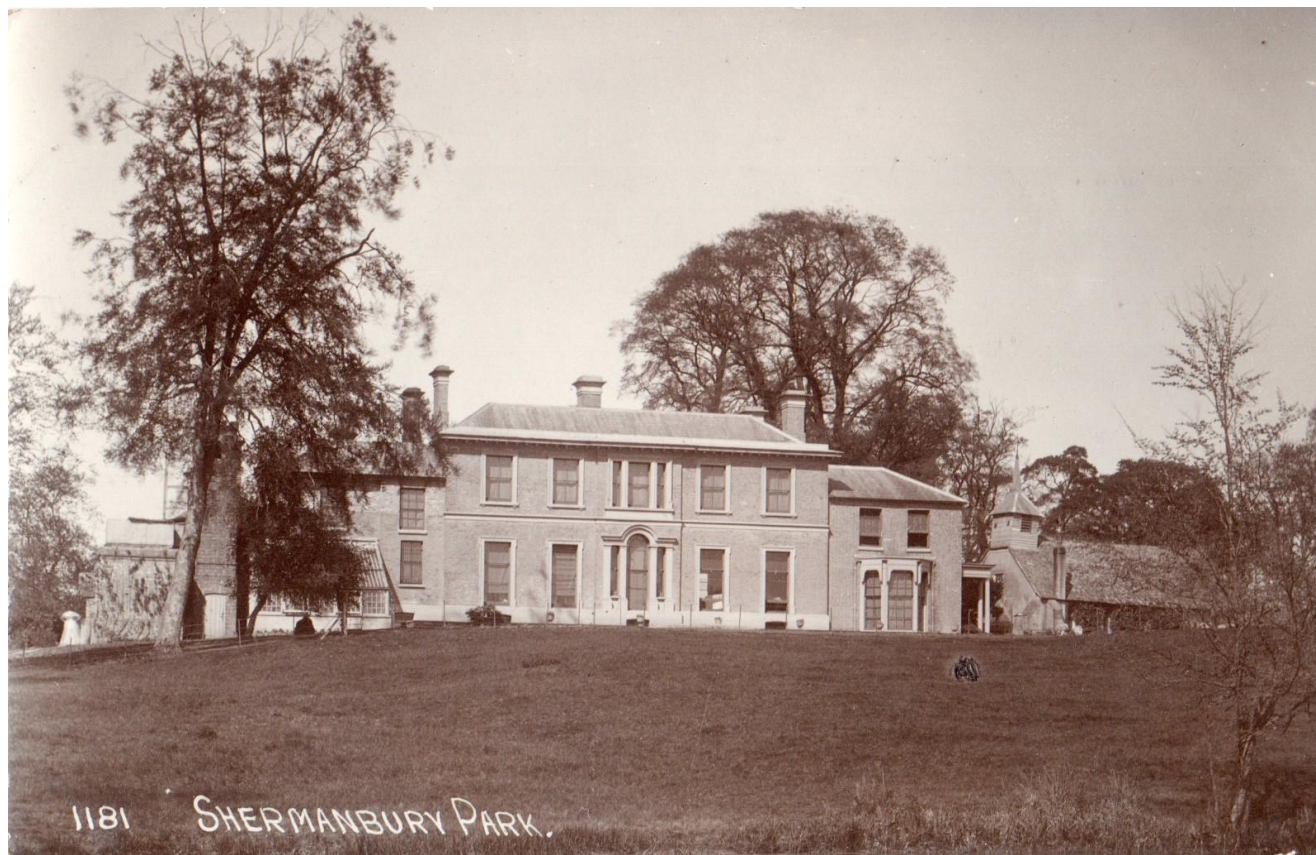
## 5. Photograph: Shermanbury Park (viewed from South Front)

Circa later 19<sup>th</sup> century date. An additional story has also now been added to the west wing to make the housefront symmetrical, with the glasshouse also seemingly replaced at this time. The first-floor addition can be seen here in the lighter brick colour. Due to the tree, it is unclear if the clock tower remained the same, but most likely.

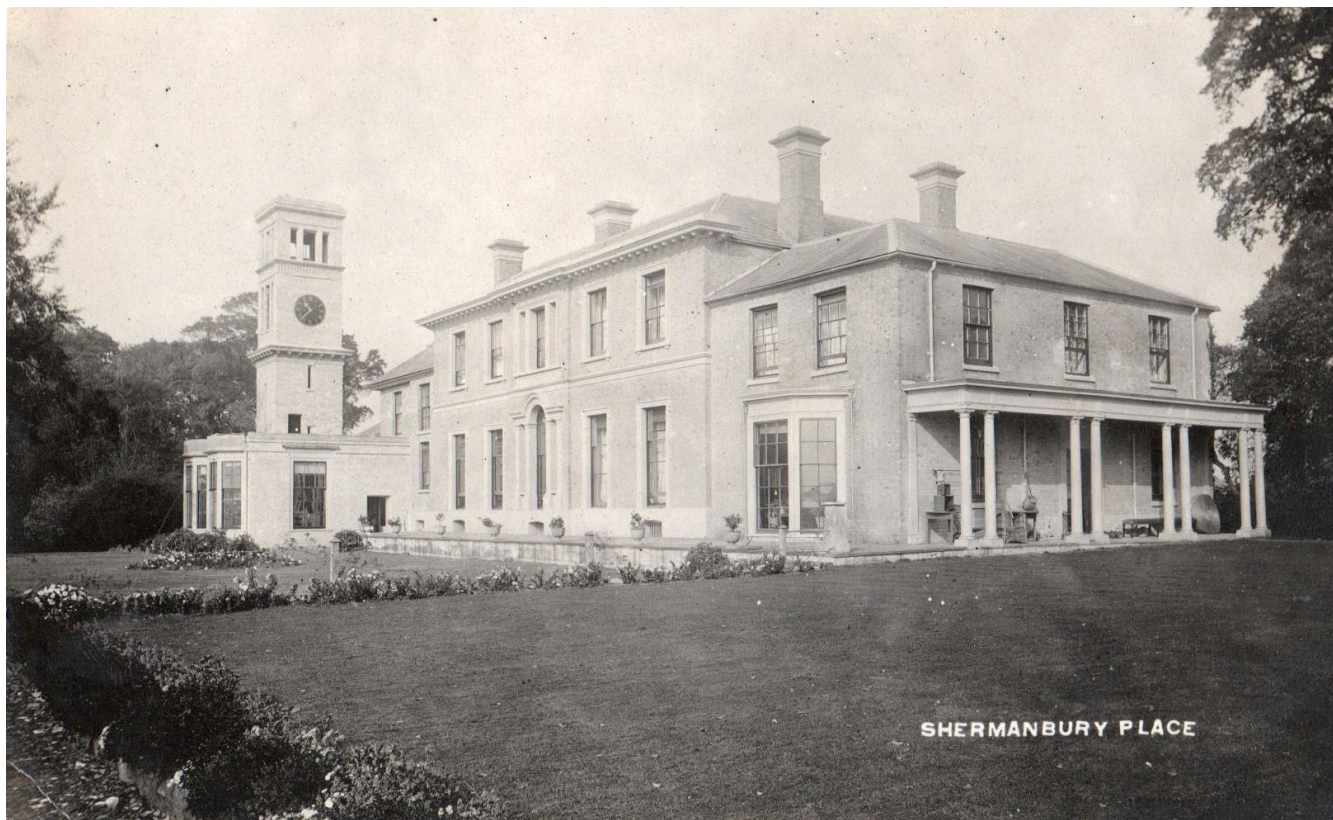
## 6. Photograph: Shermanbury Place (viewed from south-east, inc. sunroom and clocktower)

Here in this circa early 20<sup>th</sup> century view, the greatest extent of the house is seen, with the additional 'billiard room' or sun room having been added to the south west corner, alongside the impressive new clock tower.

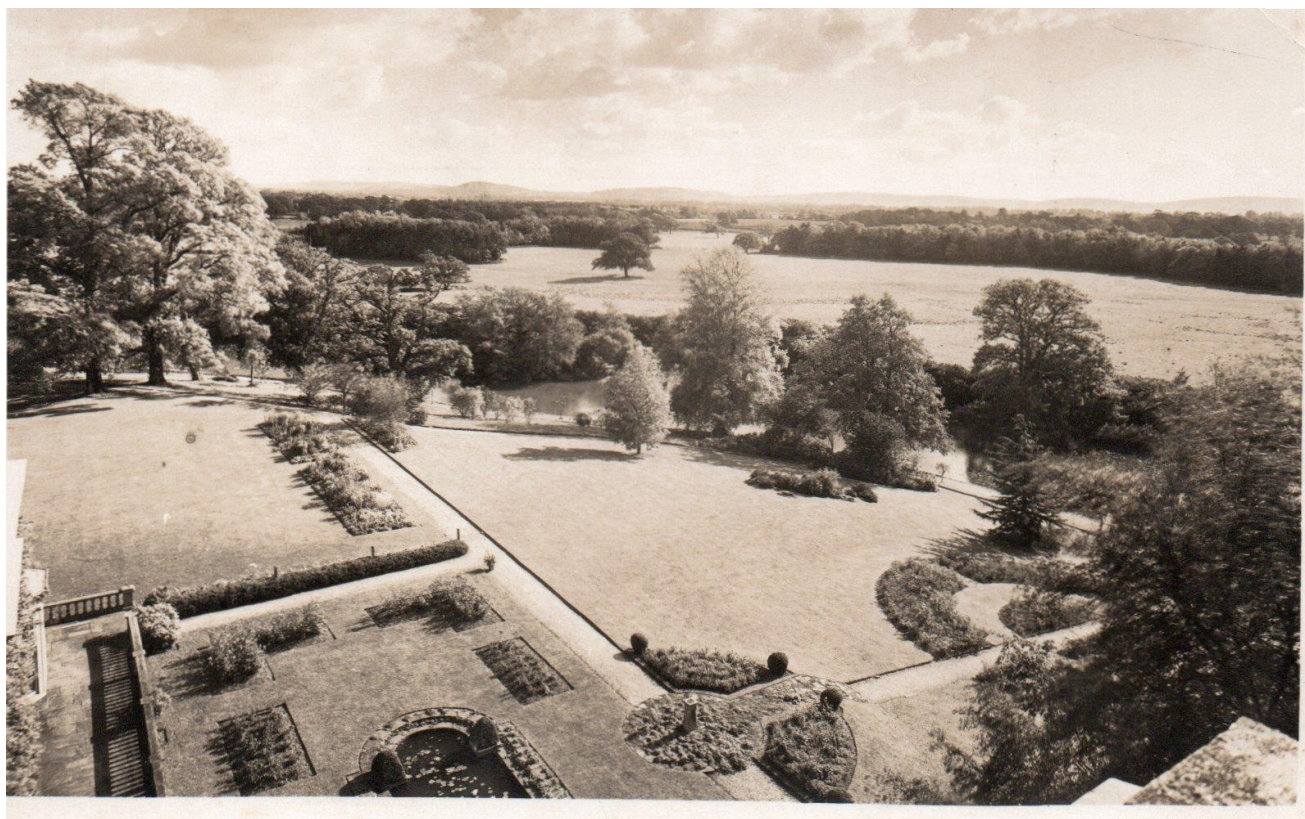
Although the central feature/pond is the only element clearly seen on the maps, the progression of the garden design is evident over the course of the photos.
