## Shermanbury Place in Historic Ordnance Survey Maps, Photos and Images (*R. S. Gordon, September 2022*)

This document aims to illustrate the changes to the Shermanbury Estate from the earliest 1813 Ordnance Survey (OS) edition via the 1840 tithe map and a series of subsequent 6 inch and 25 inch scale maps; both levels of detail included due to differing years of publication. A map drawn up for the 1879 sale brochure (likely based on an OS map) is also included.

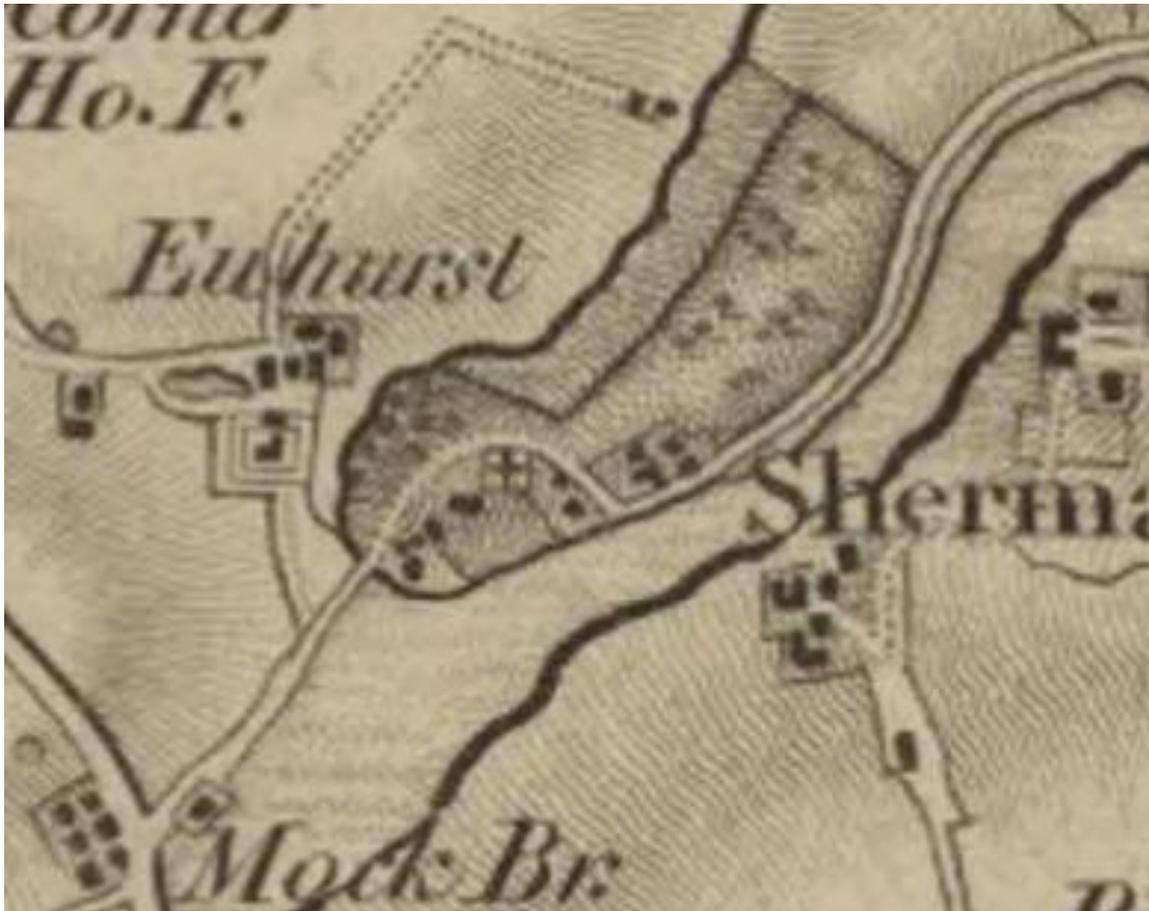
### 1. 1813 (1<sup>st</sup> edition) Ordnance Survey

The first map produced with any degree of detail on individual structures, at this stage the footprint of the house may well reflect the basic 1780 rebuild. The water mill and buildings ancillary to it and the house can be seen to the immediate south-west. The existing cottage or stables can be seen to the east of the church. Just to the east lie the four main buildings of the [Shermanbury Home Farm](#). Given the date of this map, it is likely of 18<sup>th</sup> century or earlier date.

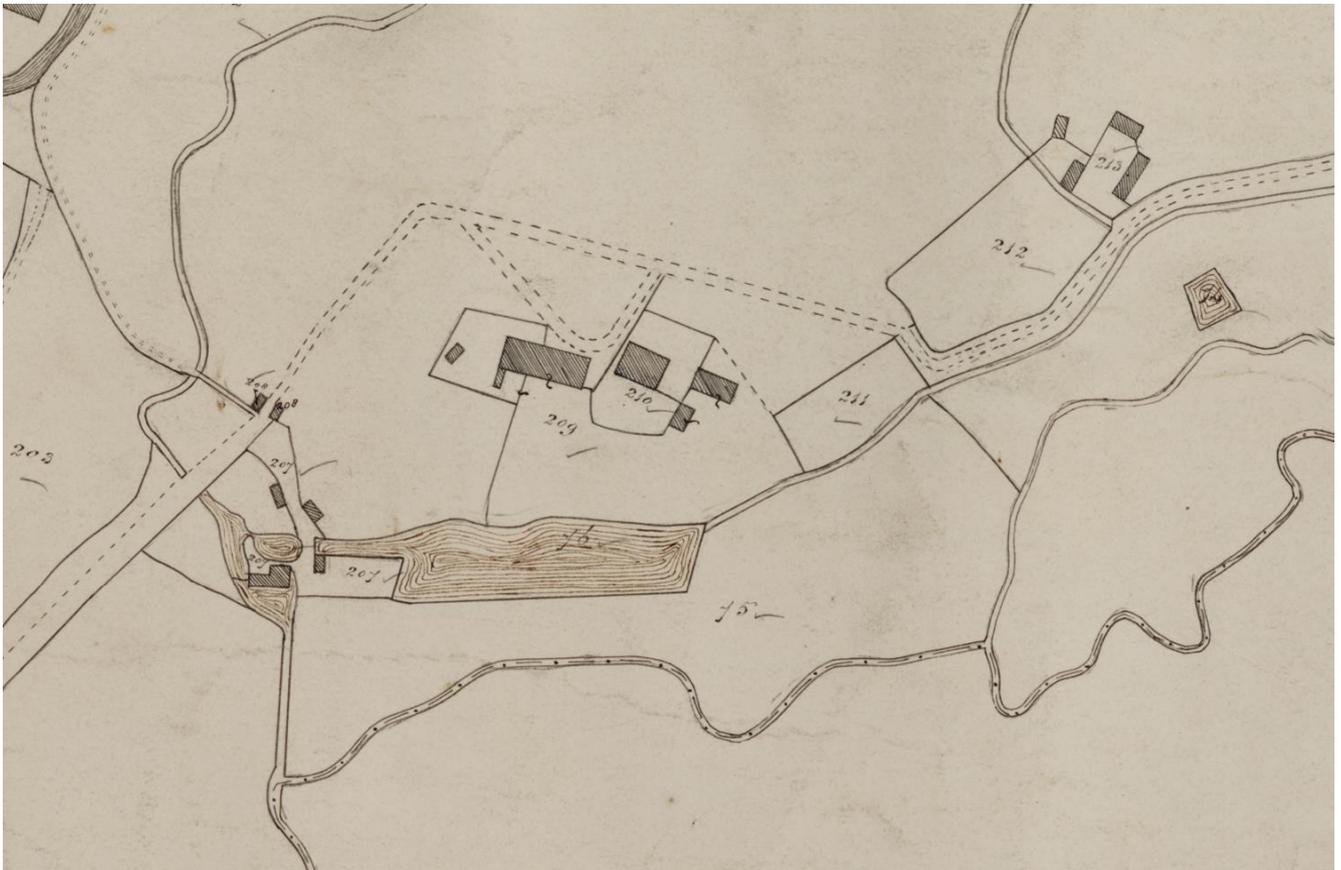
## 2. 1840 Tithe Map (H & F. Hitchins)

Surveyed by H & F. Hitchins who drew up a number of the tithe maps for Sussex parishes. Here we see a clear outline of the estate at this fairly early date. The small outbuilding to the north and attached clock tower at the north-west tip of the house can be seen. In addition, the stables and single outbuilding lie on the other side of the church. The water mill and its three associated outbuildings are seen to the west, while just above are two small buildings which the apportionment lists as the entrance lodge. The four buildings of Shermanbury Home Farm are seen to the south-east.

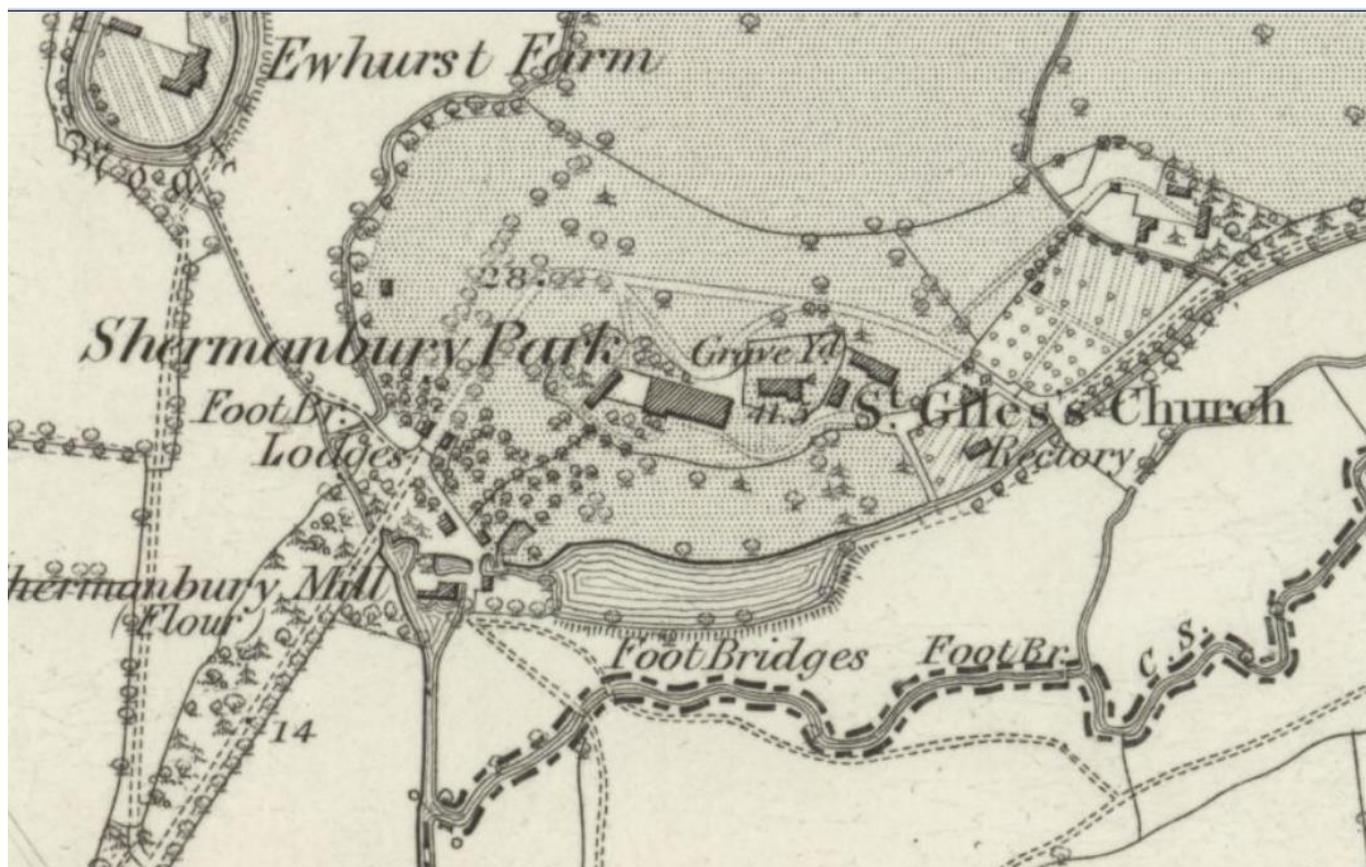
### 3. 1874-5 Ordnance Survey (6 inch, published 1879)

With the increased detail of the new edition OS maps, a clear picture can be seen. A subsequently removed long outbuilding sits west of the house. The stables are seen east of the church, along with the still existing cottage. In the 1917 sale brochure, the stables are noted as also containing the coachhouse and blacksmith's shop.

A building appears to be marked as 'Rectory'. It is possible this was the old rectory prior to the mid-19<sup>th</sup> century construction of the replacement further east at Wyndham (Wineham), but perhaps more so that the label is either mistaken or simply intended to be appended as part of the church text above. The 1879 schedule notes this plot (211) as the kitchen garden, but doesn't mention the building. The 1917 sale brochure notes this plot as a walled kitchen and fruit garden with *'a lean-to range of glass houses with brick and tiled potting sheds.'* It also notes the structure presumably seen here as *'a Gardener's appropriate brick and tiled Cottage containing four rooms.'*

North-east Shermanbury Home Farm is seen for the final time on a map. The 1879 sale brochure notes that the buildings (213: Granary, barn, shedding) were all of wood, so the lack of any later trace follows. The 1917 sale brochure as a result later refers to Ewhurst Manor and its associated Farm Yard to the north (1879 schedule: 241) as the 'Home Farm'. Below the old home farm is the orchard and garden (212, 1879 schedule).

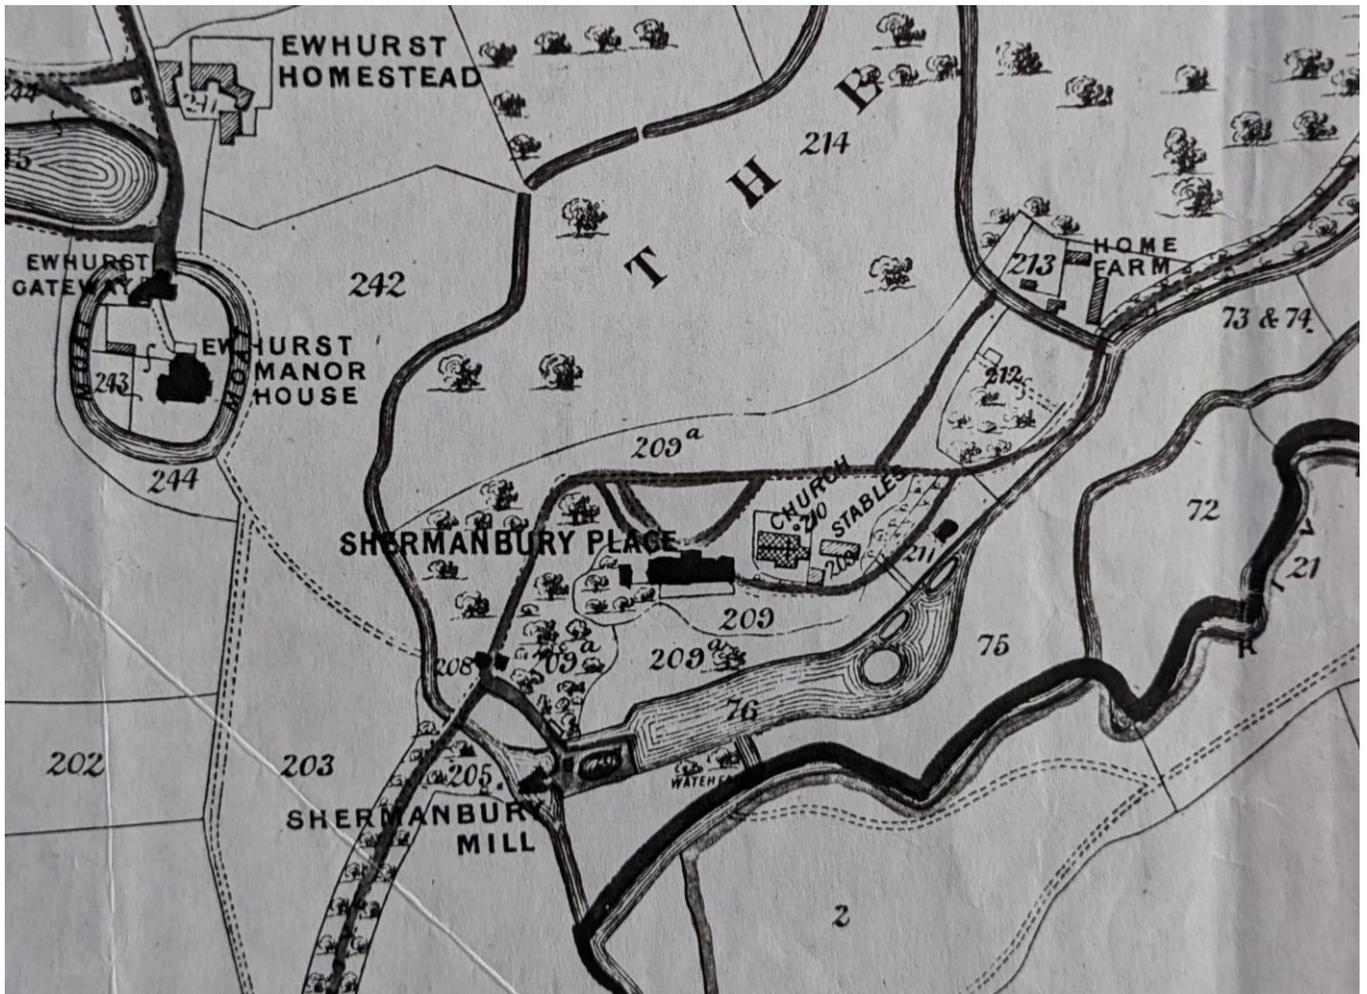
#### 4. 1879 Sale Brochure Map (Standidge & Co. Litho.)

The printers of this map appear to have been active in the early-mid 19<sup>th</sup> century, so the basis of the map likely predates the sale by some time.

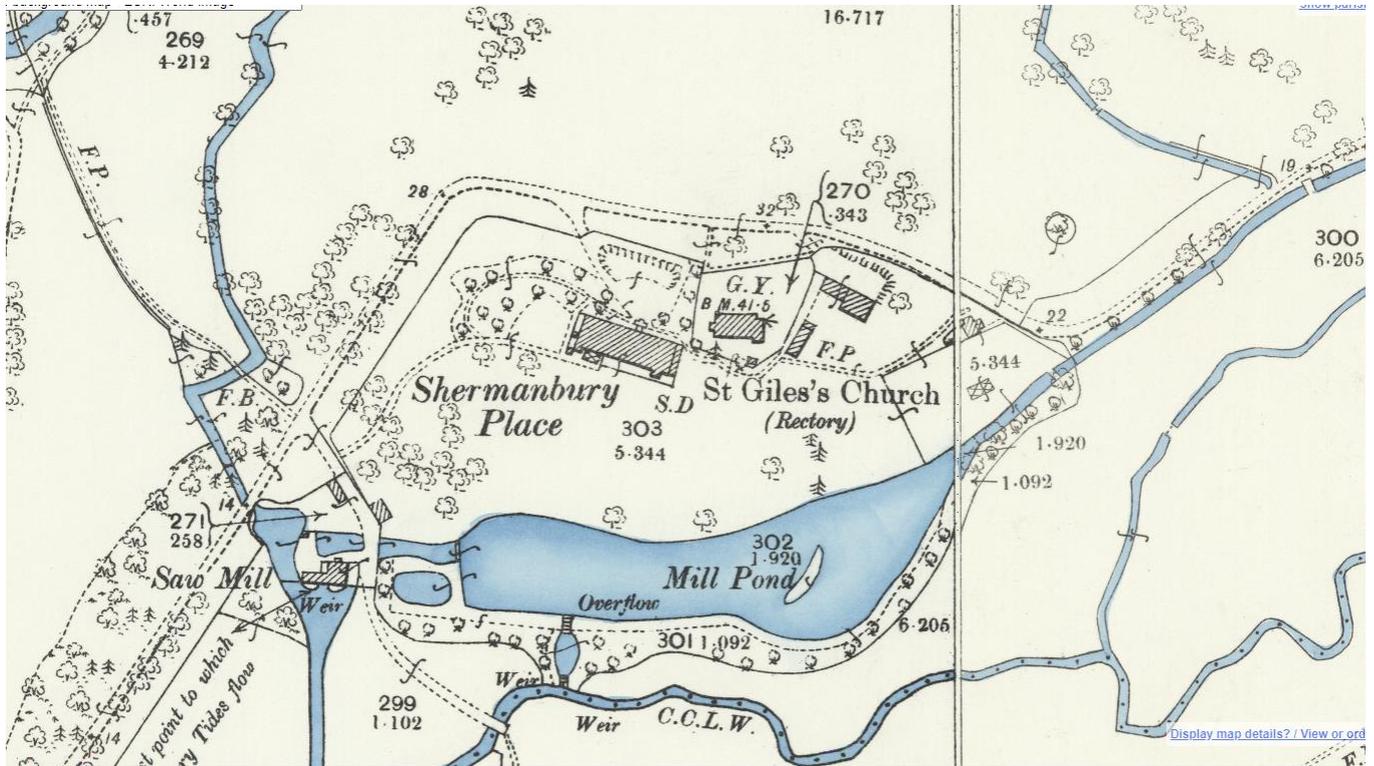
## 5. 1896 Ordnance Survey (25 inch, published 1897)

By 1896, the long stable building to the south-west of the house has gone. A small glasshouse can be seen to have been added on the west rear of the house, also seen in the undated but likely 1870s or prior drawing 'Shermanbury Place - South Front'. The smaller clock tower seen in this image can also likely be seen here on the west side. Shermanbury Farm to the north-east has now gone, although is still marked by the treeline.

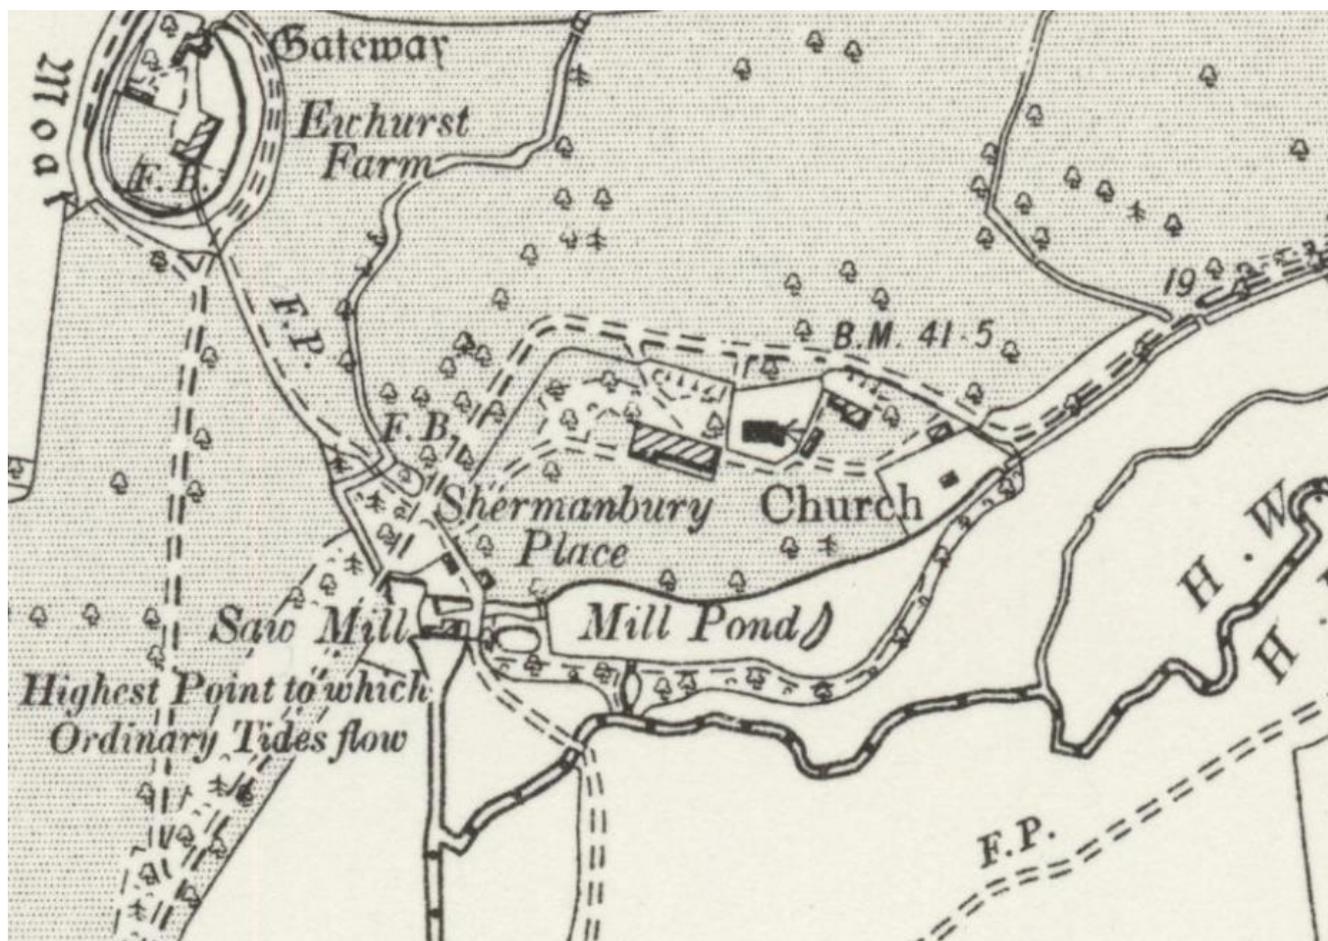
## 6. 1896 Ordnance Survey (6 inch, published 1899)

No obvious differences to the 1892 25 inch.

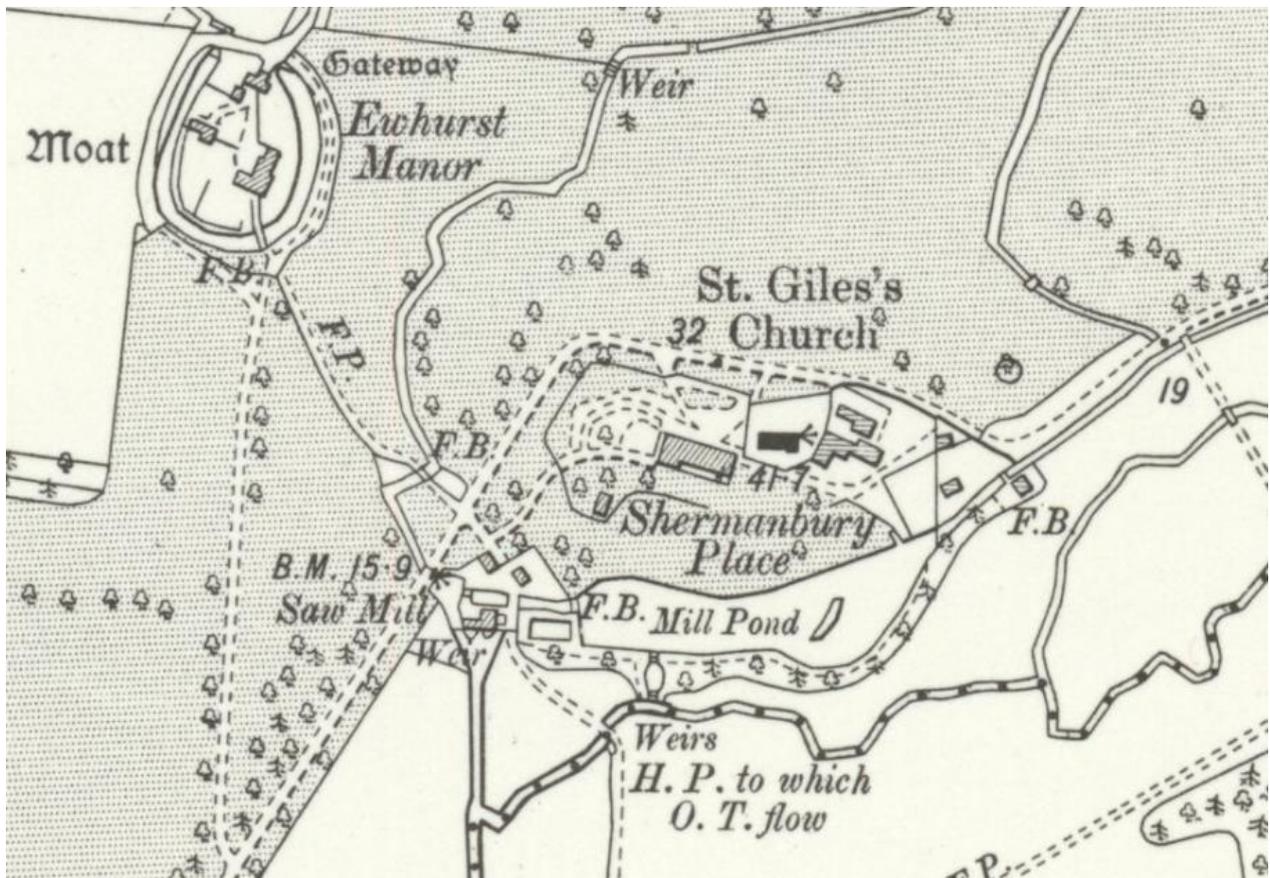
## 7. 1909 Ordnance Survey (6 inch, published 1912)

A small outbuilding appears to have been constructed just south-west of the house. Additionally, the motor garage and chauffeur's house behind the stables has now been constructed along with a club house and engine shed noted in the 1917 sale brochure. One of the small mill ponds has been squared off, likely forming the 60 by 30 foot swimming pool mentioned in the 1917 sale brochure. A small building has been added to the east of the 'rectory' building, perhaps relating to the weir.

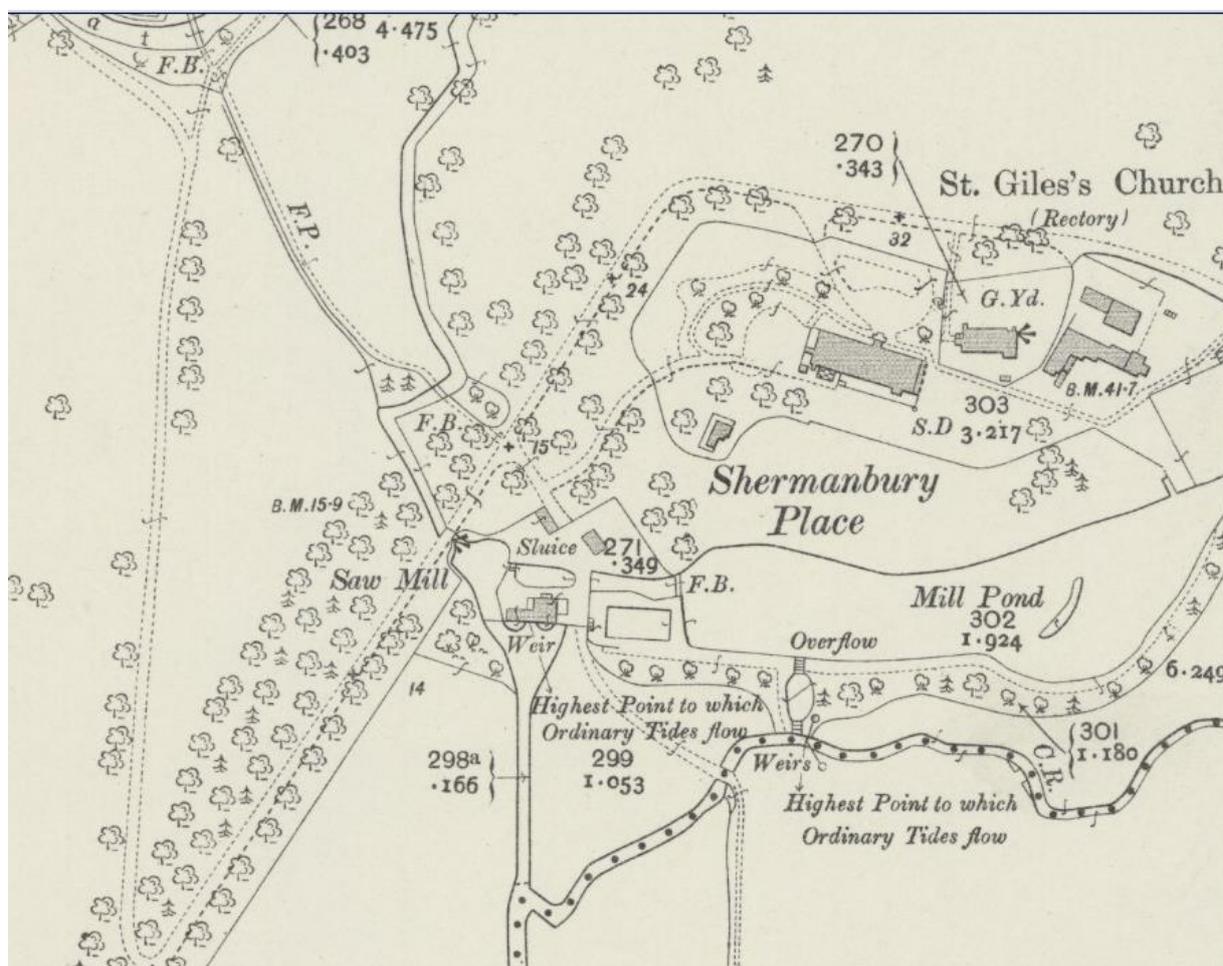
## 8. 1909 Ordnance Survey (25 inch, published 1911)

Although surveyed the same year as the 6 inch above, the increased detail here clearly shows the shape of the extant structures. Again, the adjoining glasshouse is shown here on the 25 inch, but not the 6 inch maps. As seen in the photos, at some point around this time the old glasshouse on the south side must have been replaced by the larger sunroom extension (described in the 1917 brochure as an additional billiard room) and the older clocktower being replaced by the larger new, also including lavatory and W.C. (again per 1917 sale brochure).

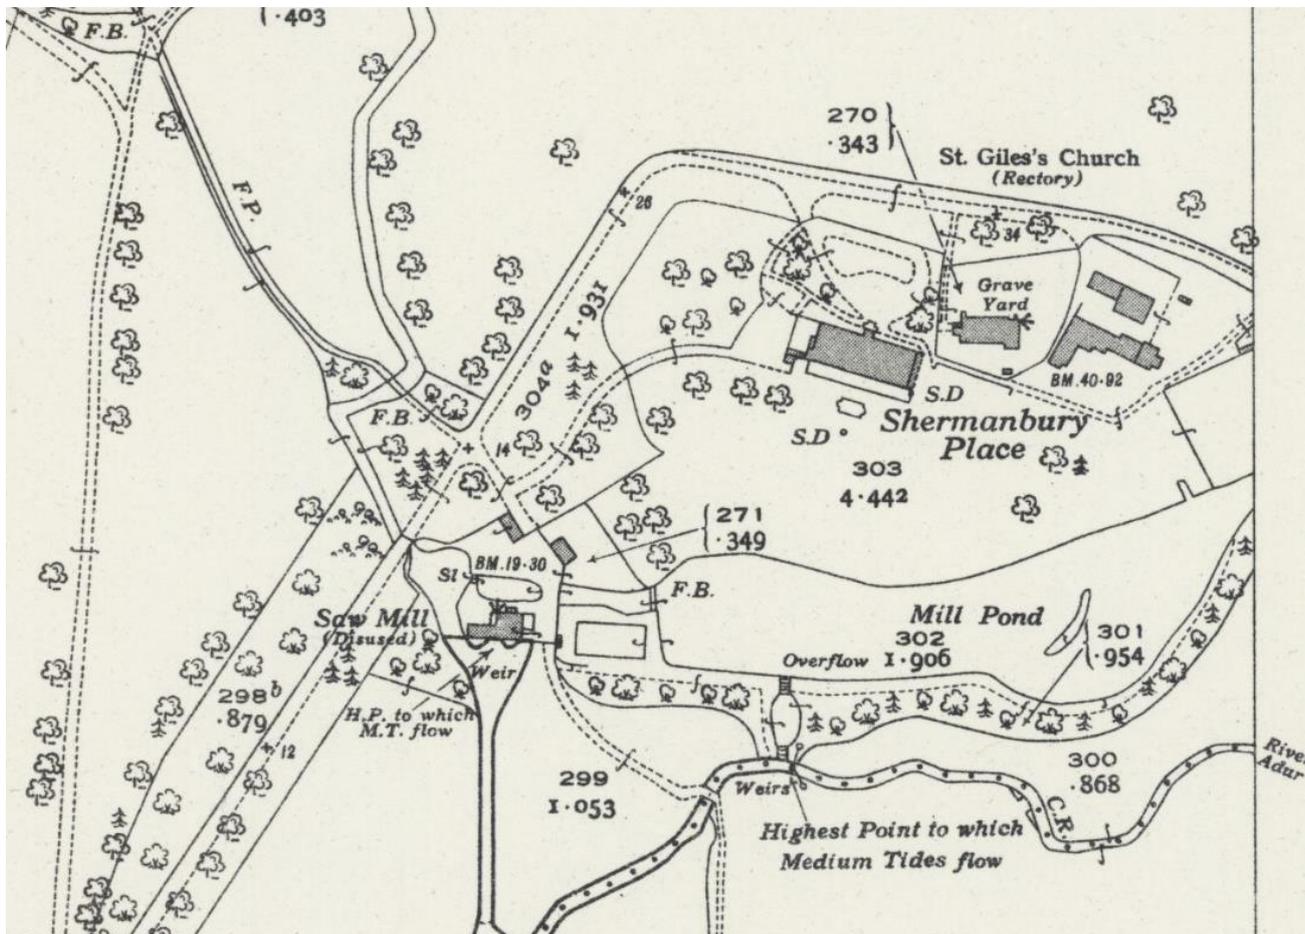
## 9. 1938 Ordnance Survey (25 inch, published 1941)

Small outbuilding to immediate south-west of the house now gone again, along with the glasshouse adjoining the south of the house.

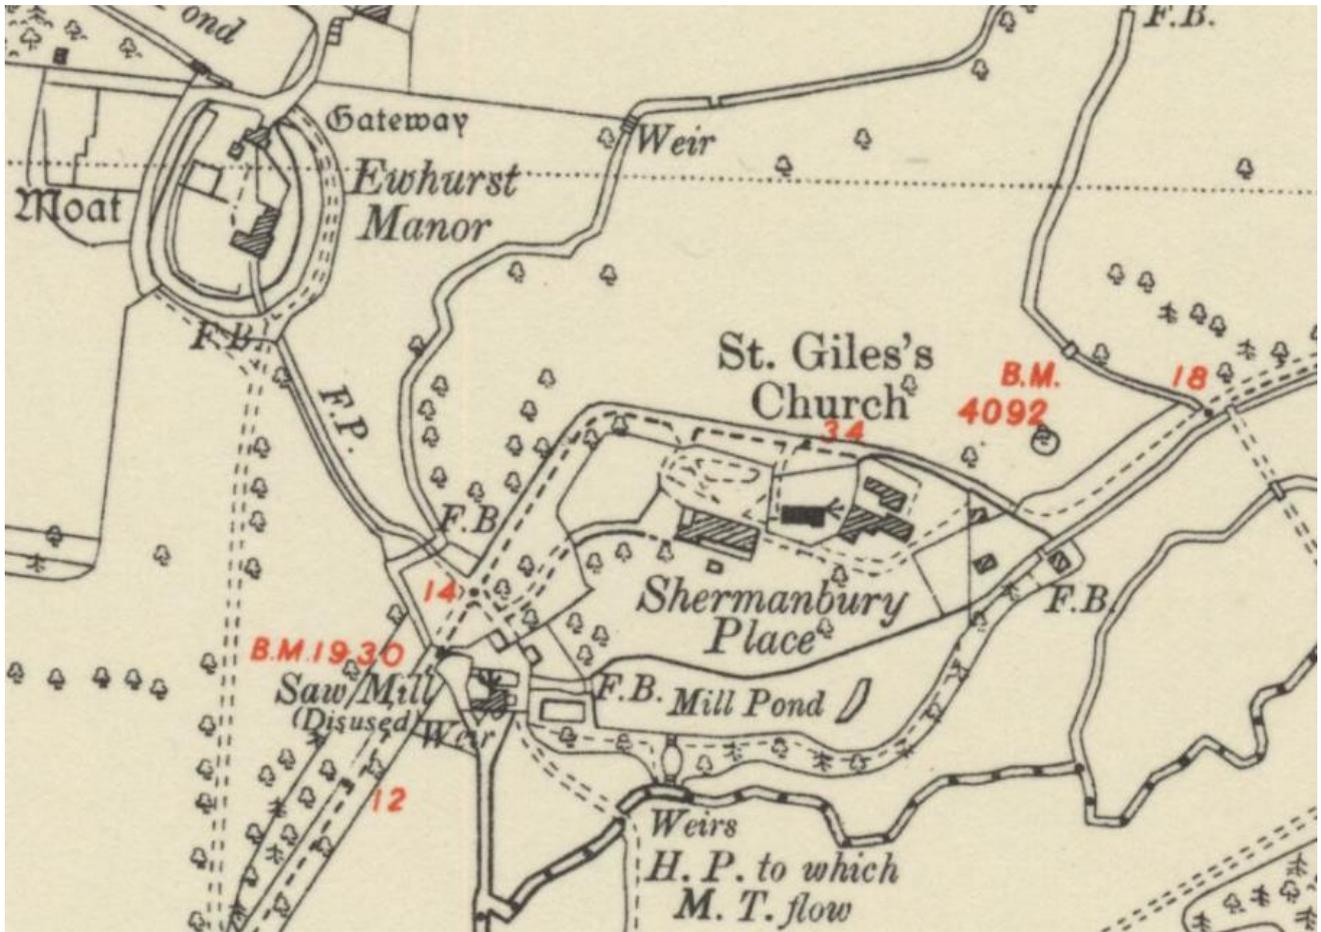
## 10. 1946-47 Ordnance Survey (6 inch, published c. 1952)

Same as above. Small former 'rectory' building to the south-east still extant. Main mill building seen just prior to demolition.

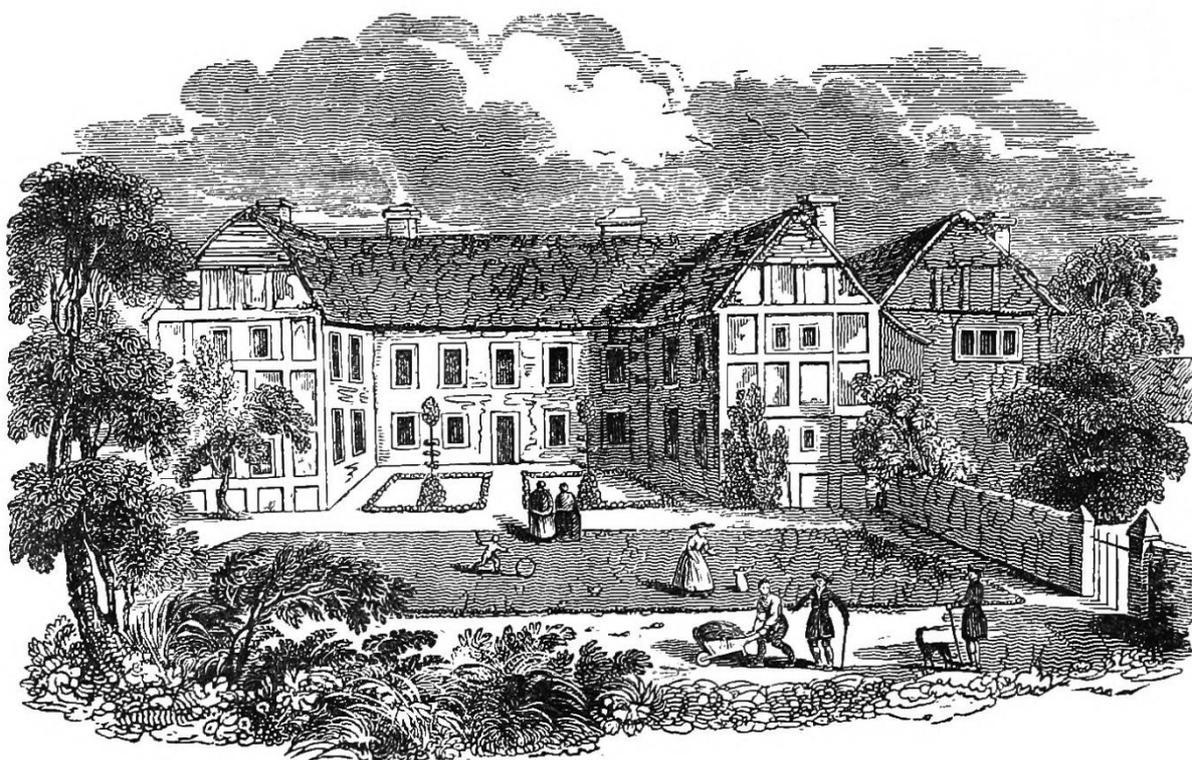
### 1. Drawing: Shermanbury Place (Tudor residence of the Combers)

This well-known image is included in both Edmund Cartwright's *The Parochial Topography of the Rape of Bramber, in the Western Division of the County of Sussex, Vol. 2, Part 2* (1830) and Thomas Horsfield's *The history, antiquities, and topography of the county of Sussex* (1835). We see the Tudor mansion of the prominent 16th-17th century Comber family. Cartwright notes it as originally from the 'Burrell collection' – likely that of the Burrell Baronetcy of West Grinstead, i.e. Knepp (and no connection to the modern collection of the name in Glasgow), most of which was destroyed in a devastating fire in 1904.

Although there is no date given, this drawing appears to be late 17<sup>th</sup> - mid 18<sup>th</sup> century, by the style of dress. Built on presumably roughly the same site as the current house, William Comber had bought the lease of the manor from Lord Sandys in 1542; he or his son John are most likely to have initiated the new construction. It was recorded as demolished by John Challen Esq. in 1779, having replaced another manor house [recorded on the site](#) in its own turn.

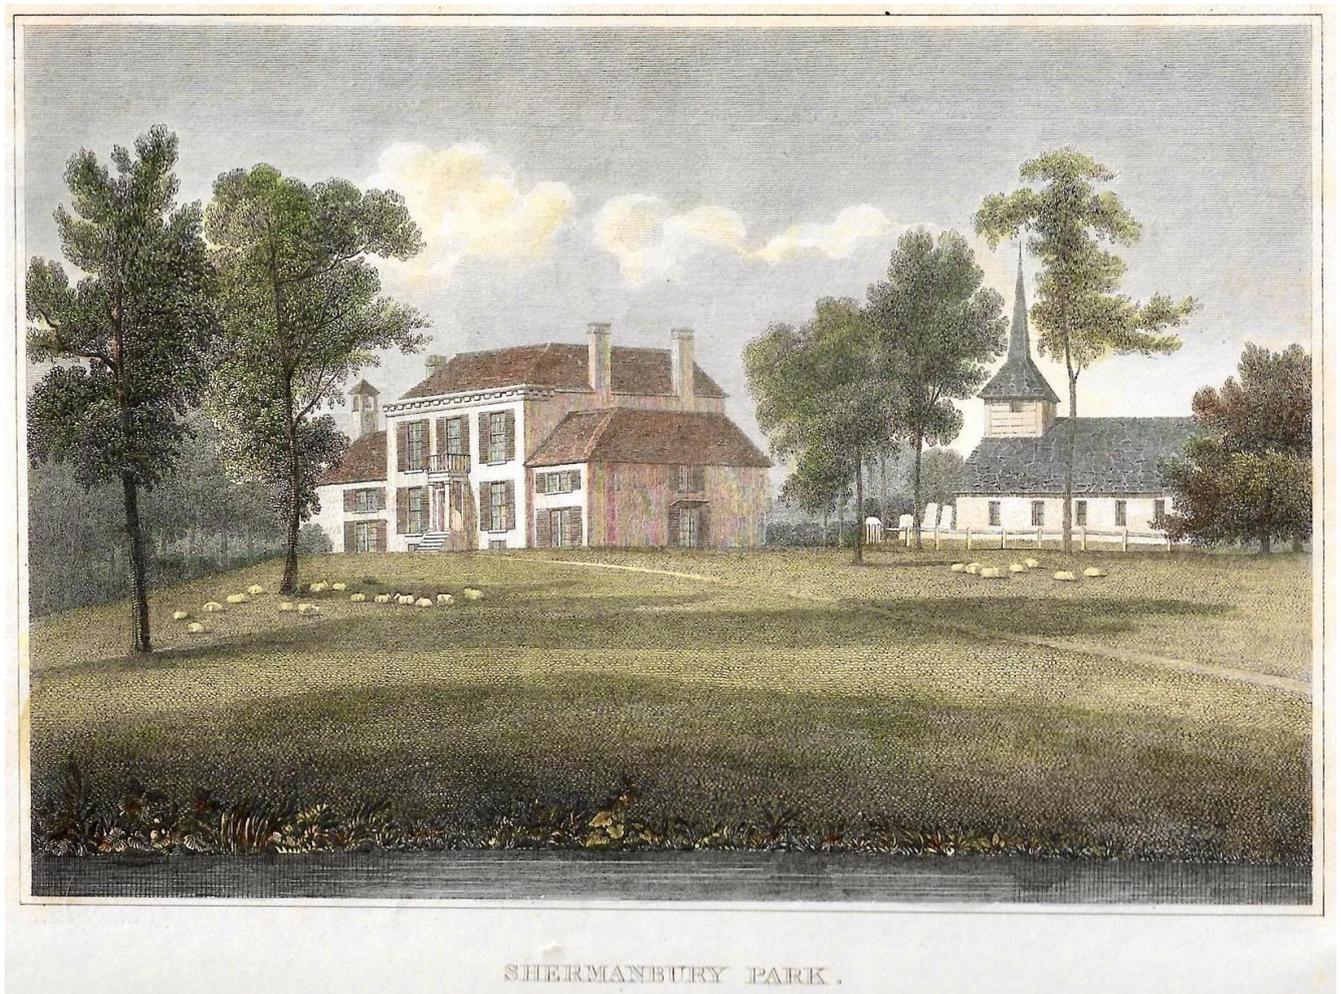
## 2. Engraving: 'Shermanbury Park' (early view from south-east)

This is a fairly well known image, also appearing in Horsfield (ibid), [where he notes](#) that it was provided to him by the current occupant, the Rev. John Gratwick Challen. This seems likely to be the form of John Challen Esq.'s functional 1780 rebuild of the house, or close to it. At this stage the house appears surrounded by simple parkland without the ornamental gardens of the earlier Tudor mansion or later iterations of the new. At least one of the low, but still two story wings likely hosted the servants' quarters.

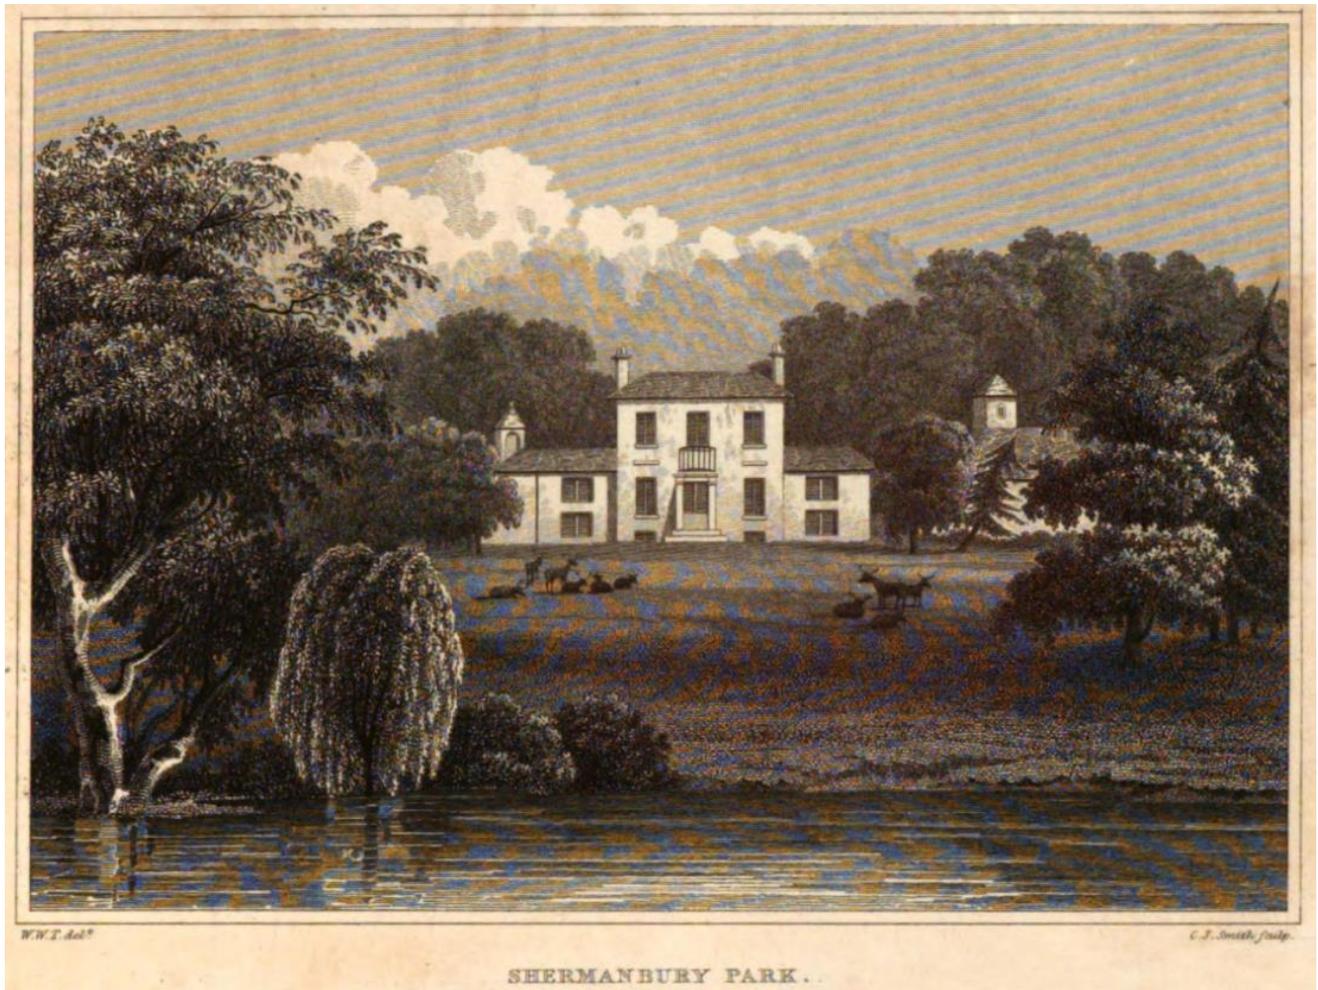
### 3. Engraving: 'Shermanbury Park' (early view from south)

Another image of the post 1780 rebuild state of the house, this from Cartwright (1830, *ibid*). The clock tower was clearly an original or early feature, perhaps also designed to be somewhat complementary to that of St. Giles'.

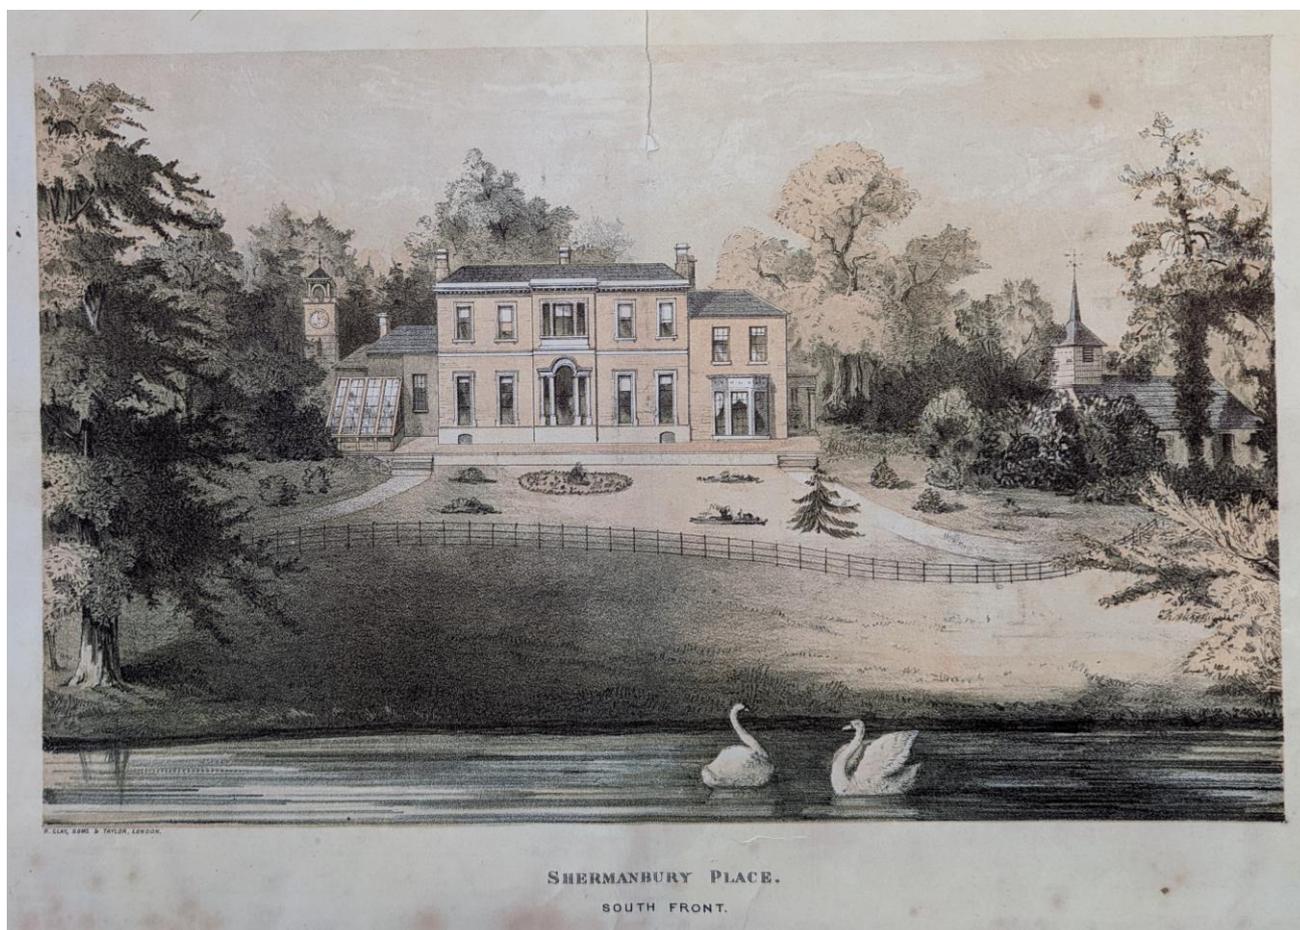
#### 4. Shermanbury Place, South Front

This image may have been drawn for the sale, but may also predate it. Although the house has the same basic form to the above two images, substantial alterations must have occurred in the decades separating them, with the central portion of the house extending from three to five bays and a more spacious first floor being added over the east wing. A simple garden has also now been laid out.

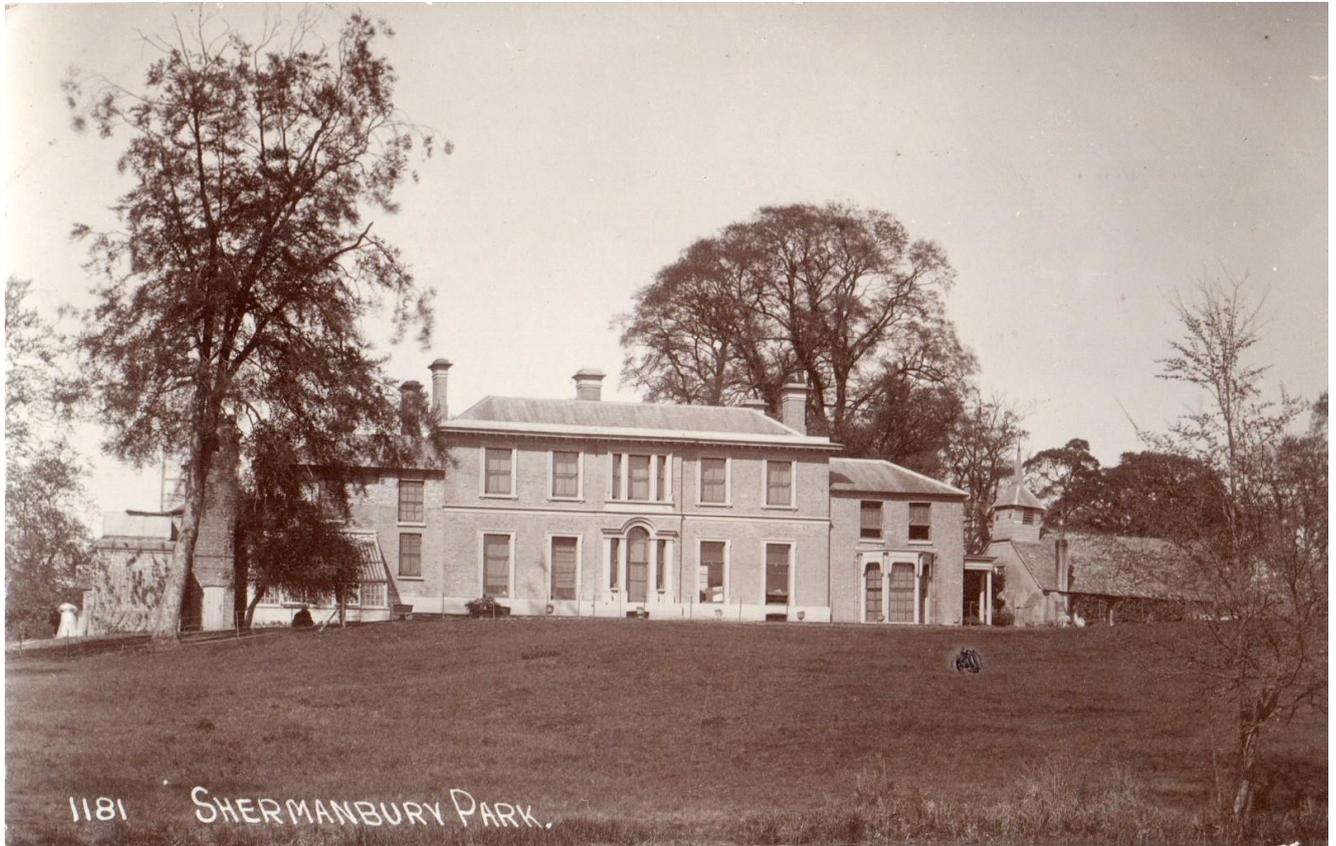
## 5. Photograph: Shermanbury Park (viewed from South Front)

Circa later 19<sup>th</sup> century date. An additional story has also now been added to the west wing to make the housefront symmetrical, with the glasshouse also seemingly replaced at this time. The first-floor addition can be seen here in the lighter brick colour. Due to the tree, it is unclear if the clock tower remained the same, but most likely.

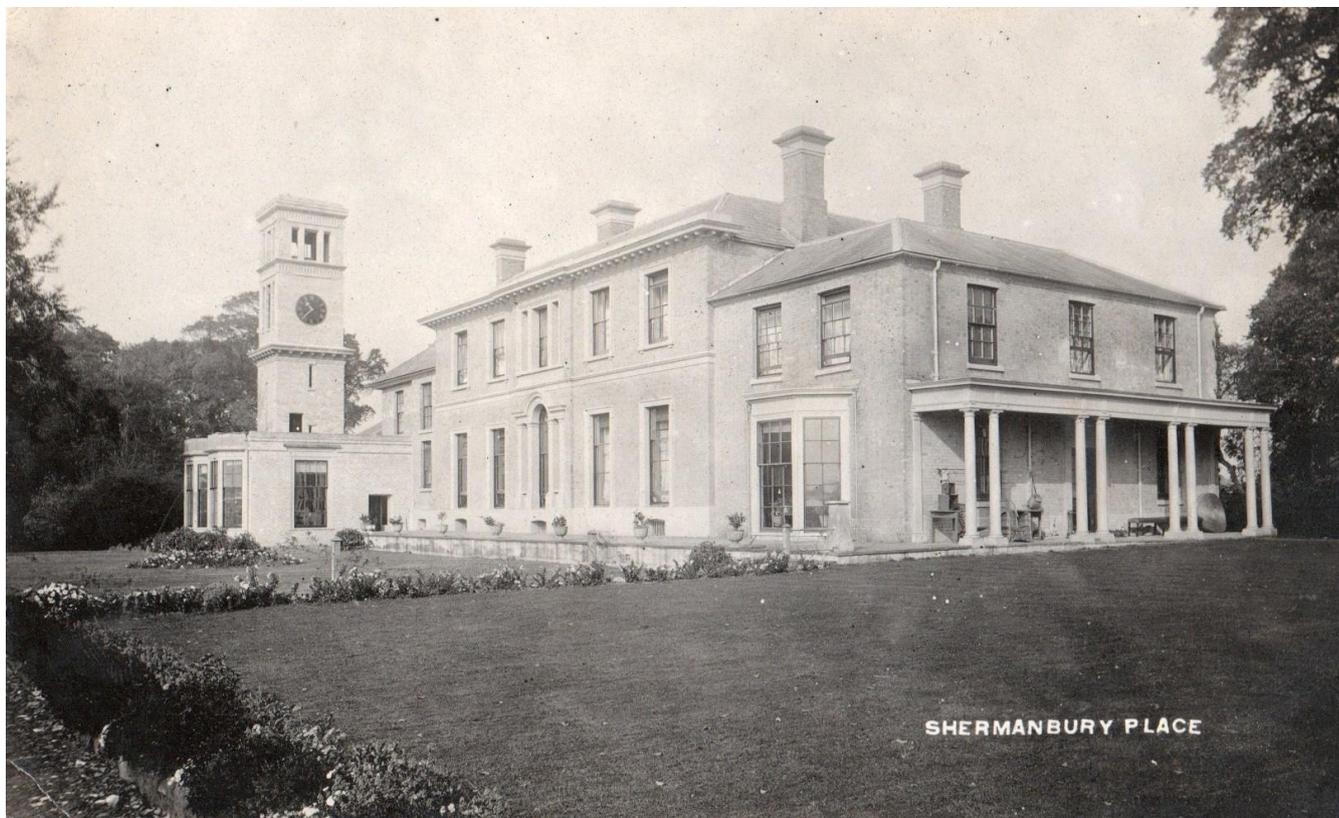
## 6. Photograph: Shermanbury Place (viewed from south-east, inc. sunroom and clocktower)

Here in this circa early 20<sup>th</sup> century view, the greatest extent of the house is seen, with the additional 'billiard room' or sun room having been added to the south west corner, alongside the impressive new clock tower.

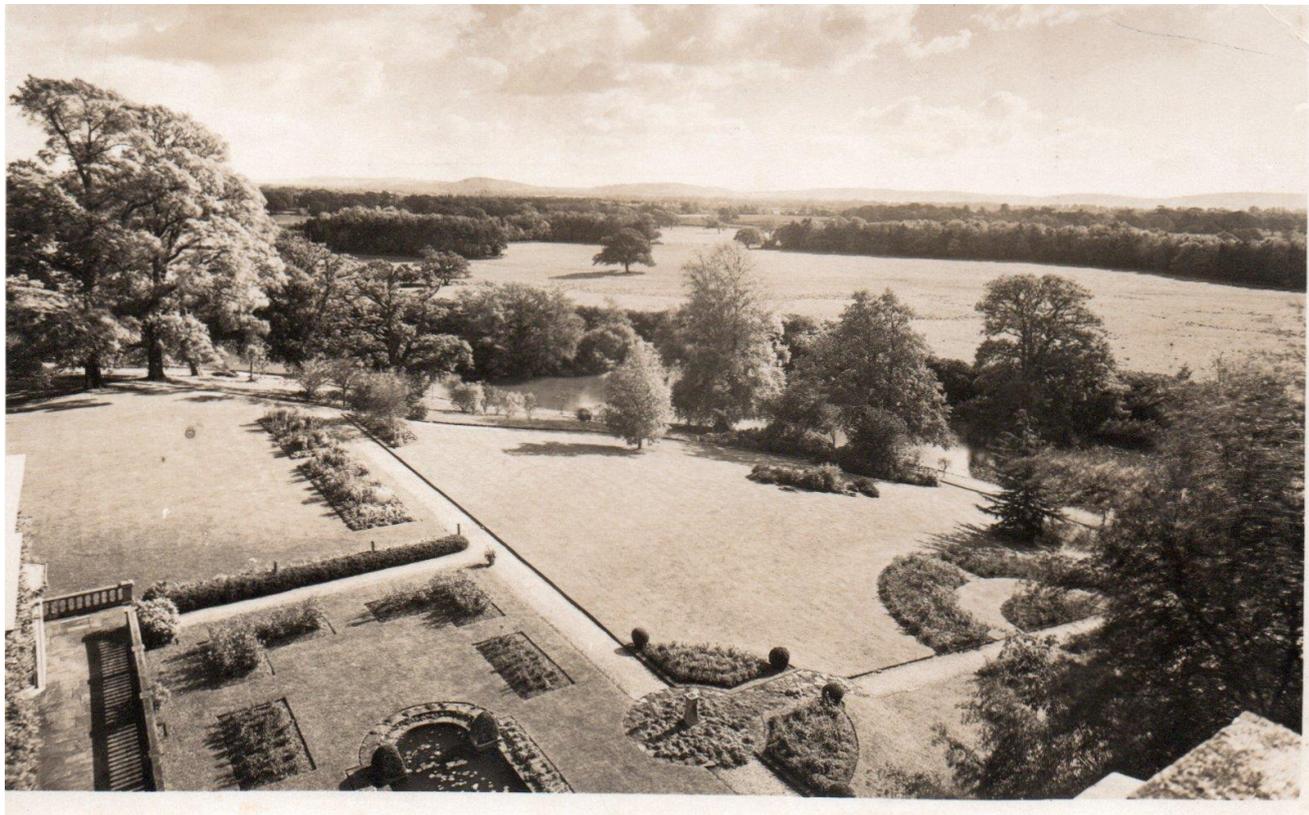
## 7. Photograph: Shermanbury Place ornamental garden, view south-east from clocktower

Although the central feature/pond is the only element clearly seen on the maps, the progression of the garden design is clearly seen over the course of the photos.
